# Access Compliance Report

## Public Rights-of-Way

### (Curb Ramps)

| Intersection ID: 13442 | Main Street: MORRIS_FIELD_DR | Cross Street: AIRPORT_CENTER_PY | Location: SE |

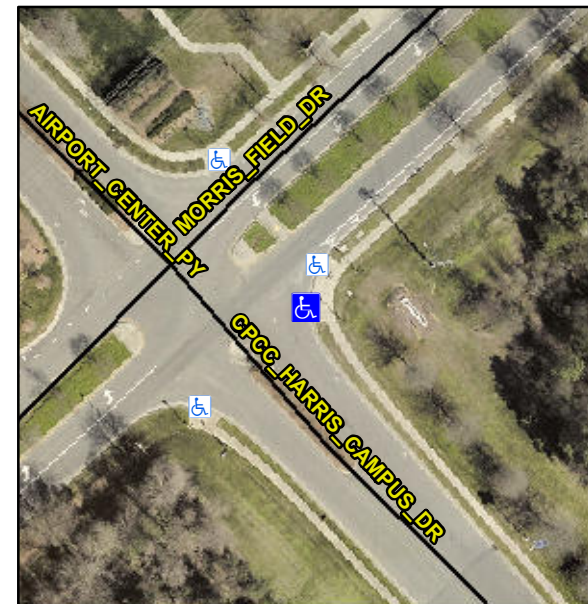
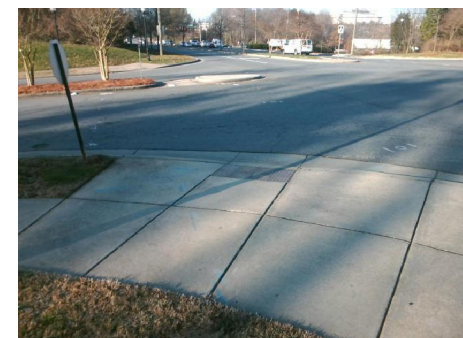
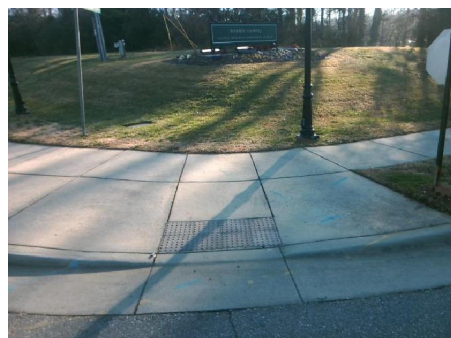
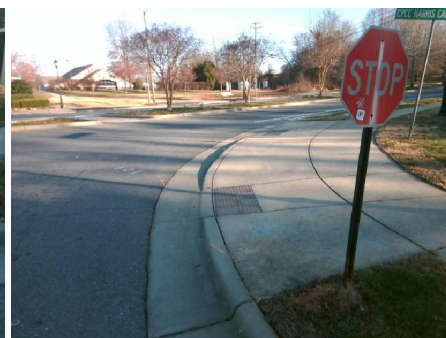
| ADA ID: 0C18D189C10B | Ramp Type: Perp | Initial Pass/Fail: Fail | Overall Compliance: No |
| Severity Score: 21.25 | | | |

**R304.5.1, R304.5.3**

| Compliance | Description | Data | Compliance | Description | Data |
|---|---|---|---|---|---|
| N/A | Ramp Length (in) | 72.0 | Yes | Ramp Slope (%) | 6.6 |
| No | Ramp Width (in) | 46.0 | No | Ramp XSlope (%) | 6.9 |

**Remove & Replace Entire Ramp.**

Total Cost: \$ 1850.00
