Access Compliance Report

Public Rights-of-Way

(Curb Ramps)

Intersection ID: 23044	Main Street: CARMEL_RD	Cross Street: CROSSGATE_RD	Location: W
ADA ID: 0C19DDD9B890	Ramp Type: PerpDiag	Initial Pass/Fail: Fail	Overall Compliance: No
Severity Score: 8.75			
Codes/Mitigation Info/Possible Solution		Field Measurements/Component Compliance

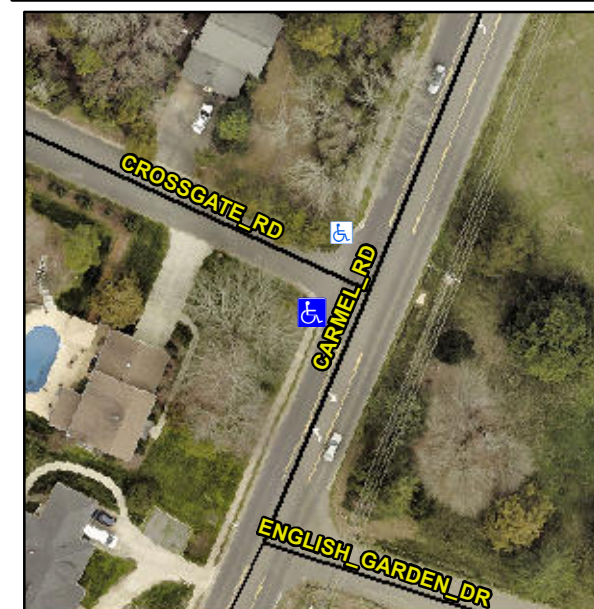
Not Found, R304.5.1

Compliance	Description	Data	Compliance	Description	Data
N/A	Ramp Length (in)	39.0	Yes	Ramp Slope (%)	7.9
No	Ramp Width (in)	47.0	Yes	Ramp XSlope (%)	0.6
N/A	Flare Type LT	N/A	N/A	Flare Type RT	N/A
N/A	Flare Slope LT (%)	N/A	N/A	Flare Slope RT (%)	N/A
N/A	Flare Traversable LT?	N/A	N/A	Flare Traversable RT?	N/A
N/A	Landing Length (in)	N/A	N/A	DWS Provided?	N/A
N/A	Landing Width (in)	N/A	N/A	DWS Contrast?	N/A
N/A	Landing Slope (%)	N/A	N/A	DWS Length (in)	N/A
N/A	Landing X Slope (%)	N/A	N/A	DWS Full Width?	N/A
N/A	Landing Curb? (Y/N)	N/A	N/A	DWS Offset (in)	N/A
N/A	Shared Landing?	N/A			
N/A	Gutter Ponding?	N/A	N/A	Gutter Slope (%)	N/A
N/A	Gutter Lip Ht (in)	N/A	N/A	Gutter X Slope (%)	N/A
N/A	Painted X Walk1?	No	N/A	Painted X Walk2?	No
	X Walk 1 Direction	To SE		X Walk 2 Direction	To NE
N/A	X Walk 1 Width (in)	N/A	N/A	X Walk 2 Width (in)	N/A
	X Walk 1 Slope (%)	3.1		X Walk 2 Slope (%)	1.8
	X Walk 1 X Slope (%)	2.1		X Walk 2 X Slope (%)	5.9

N/A	Ramp inside XWalk1?	N/A	N/A	Ramp inside XWalk2?	N/A
	Road Slope (%)	2.5	N/A	Clear Space?	N/A
	Road X Slope (%)	8.4	N/A	Clear Space to XWalk (in)	N/A
N/A	Any Obstructions?	N/A	N/A	Storm Grate/Utility Hazard?	N/A
	Obstruction Type			Storm Grate/Utility Type	
		N/A			N/A
		Yes		Surface Condition? (G/P)	Good

Possible Solutions:

Remove & Replace Curb Ramp With Two New Directional Ramps or Equivalent.
