# Access Compliance Report

## Public Rights-of-Way (Curb Ramps)

Intersection ID: 31777	Main Street: MOCKERNUT_DR	Cross Street: PINYON_PINE_LN	Location: NE
ADA ID: 0C20EC84570F	Ramp Type: PerpDiag	Initial Pass/Fail: Fail	Overall Compliance: No
		Severity Score: 10

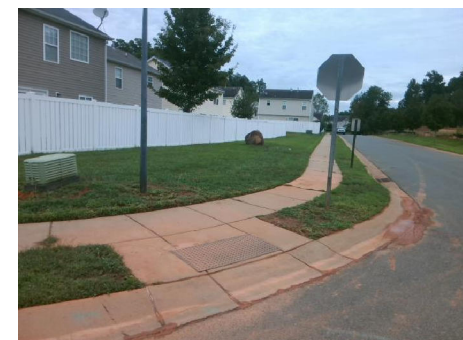
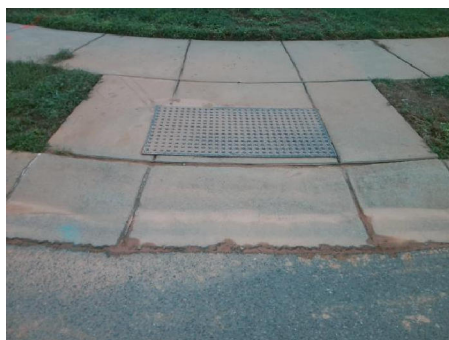
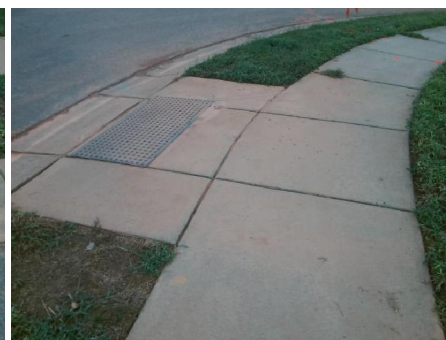
Street 1 Name **MOCKERNUT DR**  
 Stop Condition-Street 2 **None**  
 Street 2 Name **PINYON PINE LN**  
 Stop Condition-Street 1 **StopSign**
