# Access Compliance Report

## Public Rights-of-Way

### (Curb Ramps)

Intersection ID: 10020374	Main Street: BALLANTYNE CORPORATE PL	Cross Street: N/A	Location: SW
ADA ID: 0C2303E14E97	Ramp Type: Directional	Initial Pass/Fail: Fail	Overall Compliance: No
Severity Score: 10			
Codes/Mitigation Info/Possible Solution		Field Measurements/Component Compliance

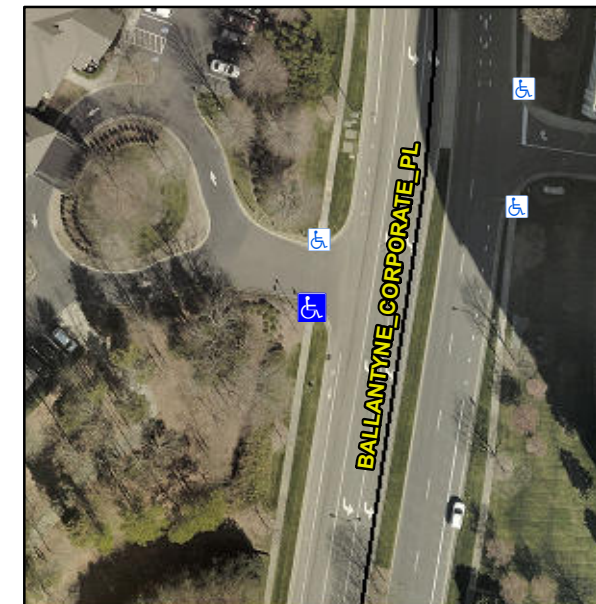
**R304.5.1, R304.5.3**

Compliance	Description	Data	Compliance	Description	Data
N/A	Ramp Length (in)	84.0	N/A	Grade Break?	N/A
No	Ramp Width (in)	46.0	N/A	Grade Break Slope (%)	0.0
Yes	Ramp Slope (%)	1.3	N/A	Grade Break XSlope (%)	0.0
No	Ramp XSlope (%)	4.4			
N/A	Flare Type LT	N/A	N/A	Flare Type RT	N/A
N/A	Flare Slope LT (%)	N/A	N/A	Flare Slope RT (%)	0.0
N/A	Flare Traversable LT?	N/A	N/A	Flare Traversable RT?	N/A
N/A	Landing Length (in)	0.0	N/A	DWS Provided?	N/A
N/A	Landing Width (in)	0.0	N/A	DWS Contrast?	N/A
N/A	Landing Slope (%)	0.0	N/A	DWS Length (in)	N/A
N/A	Landing X Slope (%)	0.0	N/A	DWS Full Width?	N/A
N/A	Landing Curb? (Y/N)	N/A	N/A	DWS Offset LT (in)	N/A
N/A	Shared Landing?	N/A	N/A	DWS Offset RT (in)	N/A
N/A	Gutter Ponding?	0.0	N/A	Gutter Slope (%)	N/A
N/A	Gutter Lip Ht (in)	0.0	N/A	Gutter X Slope (%)	N/A
N/A	Painted X Walk1?	No		Road Slope (%)	3.5
	X Walk 1 Direction	To NE		Road X Slope (%)	5.8
	X Walk 1 Width (in)	N/A		Clear Space?	N/A

X Walk 1 Slope (%)	3.5	N/A	Clear Space to XWalk (in)	N/A
	X Walk 1 X Slope (%)	5.8	N/A	Storm Grate/Utility Hazard?	N/A
N/A	Ramp inside XWalk1?	N/A		Storm Grate/Utility Type	
N/A	Any Obstructions?	N/A			N/A
	Obstruction Type		Yes	Surface Condition? (G/P)	Good
			N/A	Curb Slope (%)	2.0

**Remove & Replace Entire Ramp.**
