# Access Compliance Report

## Public Rights-of-Way (Curb Ramps)

Intersection ID: 23801	Main Street: STEPHENDALE_DR	Cross Street: S_TRYON_ST	Location: SE
ADA ID: 0C241D46C469	Ramp Type: MedianPerp	Initial Pass/Fail: Fail	Overall Compliance: No
Severity Score: 22.5			
Codes/Mitigation Info/Possible Solution		Field Measurements/Component Compliance

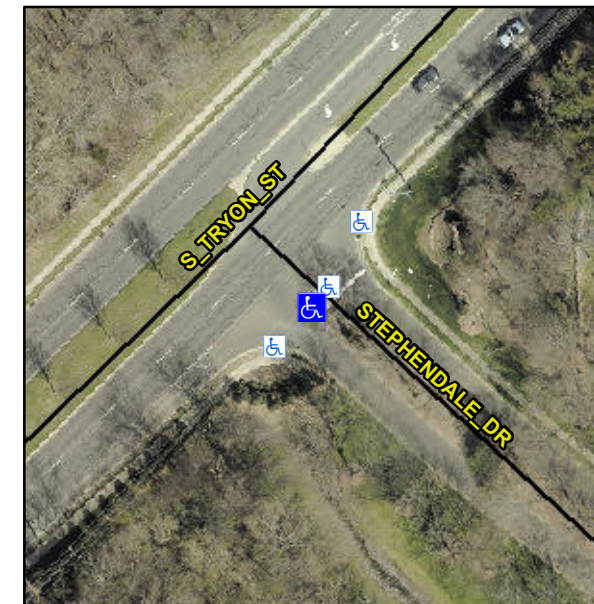
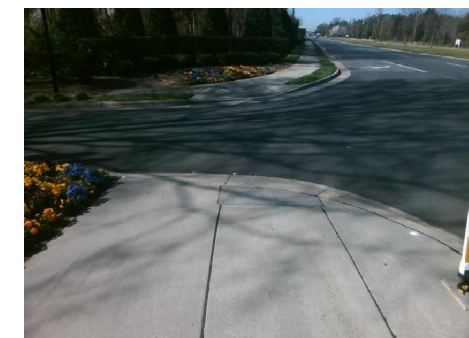
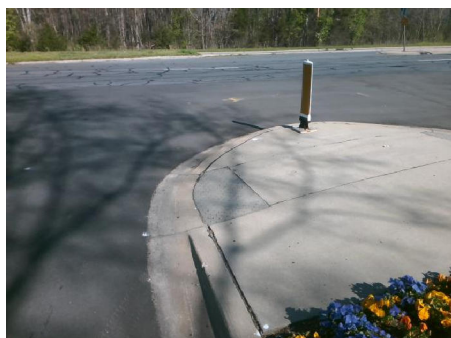
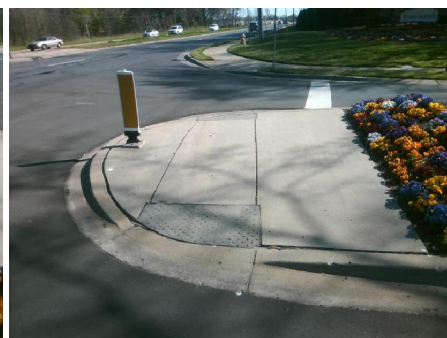
**Not Found, R304.5.1, R304.2.2**

Compliance	Description	Data	Compliance	Description	Data
N/A	Ramp Length (in)	81.0	No	Ramp Slope (%)	8.9
No	Ramp Width (in)	44.0	Yes	Ramp XSlope (%)	3.6
N/A	Flare Type LT	N/A	N/A	Flare Type RT	N/A
N/A	Flare Slope LT (%)	N/A	N/A	Flare Slope RT (%)	N/A
N/A	Flare Traversable LT?	N/A	N/A	Flare Traversable RT?	N/A
N/A	Landing Length (in)	N/A	N/A	DWS Provided?	N/A
N/A	Landing Width (in)	N/A	N/A	DWS Contrast?	N/A
N/A	Landing Slope (%)	N/A	N/A	DWS Length (in)	N/A
N/A	Landing X Slope (%)	N/A	N/A	DWS Full Width?	N/A
N/A	Landing Curb? (Y/N)	N/A	N/A	DWS Offset (in)	N/A
N/A	Shared Landing?	N/A			
N/A	Gutter Ponding?	N/A	N/A	Gutter Slope (%)	N/A
N/A	Gutter Lip Ht (in)	N/A	N/A	Gutter X Slope (%)	N/A
N/A	Painted X Walk1?	No	N/A	Painted X Walk2?	N/A
	X Walk 1 Direction	To SW		X Walk 2 Direction	N/A
N/A	X Walk 1 Width (in)	N/A	N/A	X Walk 2 Width (in)	N/A
	X Walk 1 Slope (%)	1.0		X Walk 2 Slope (%)	N/A
	X Walk 1 X Slope (%)	6.5		X Walk 2 X Slope (%)	N/A

N/A	Ramp inside XWalk1?	N/A	N/A	Ramp inside XWalk2?	N/A
	Road Slope (%)	N/A	N/A	Clear Space?	N/A
	Road X Slope (%)	N/A	N/A	Clear Space to XWalk (in)	N/A
N/A	Any Obstructions?	N/A	N/A	Storm Grate/Utility Hazard?	N/A
	Obstruction Type			Storm Grate/Utility Type	
		N/A			N/A
		Yes		Surface Condition? (G/P)	Good

**Remove & Replace Entire Ramp.**
