# Access Compliance Report

## Public Rights-of-Way

### (Curb Ramps)

Intersection ID: 50664	Main Street: CRAIGHILL_LN	Cross Street: WITHERS_RD	Location: SW
ADA ID: 0C45E6313F0F	Ramp Type: Perp	Initial Pass/Fail: Fail	Overall Compliance: No
Severity Score: 12.5			
Codes/Mitigation Info/Possible Solution		Field Measurements/Component Compliance

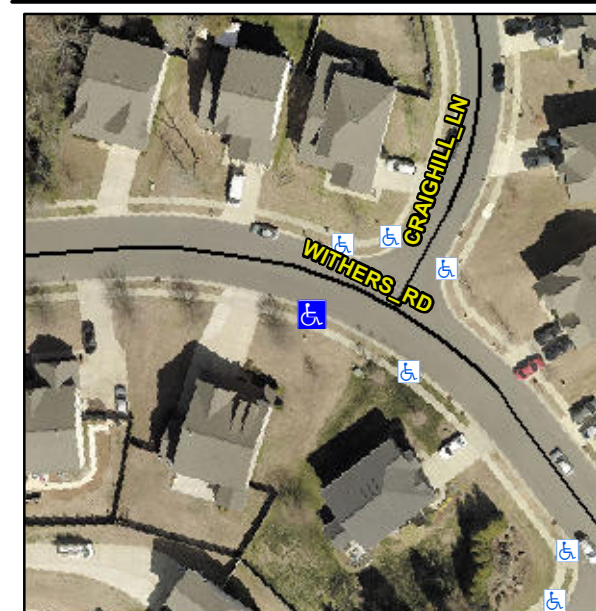
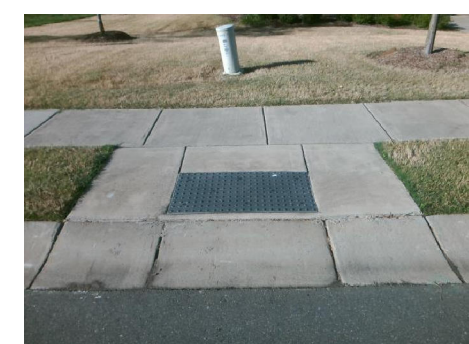
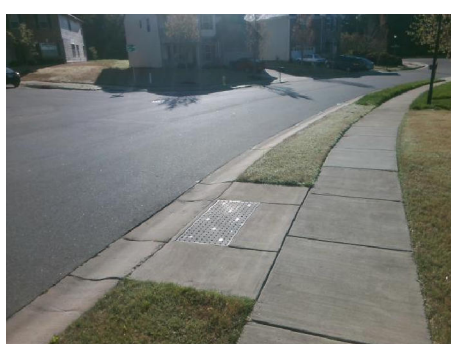
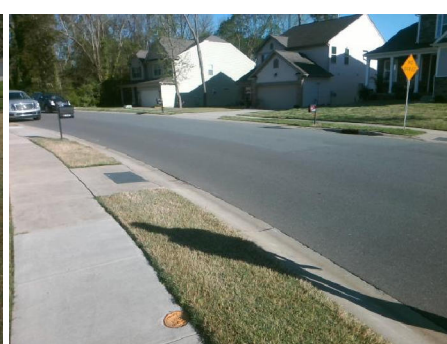
**Not Found, R304.2.2**

Compliance	Description	Data	Compliance	Description	Data
N/A	Ramp Length (in)	48.0	No	Ramp Slope (%)	8.7
Yes	Ramp Width (in)	48.0	Yes	Ramp XSlope (%)	2.0
N/A	Flare Type LT	N/A	N/A	Flare Type RT	N/A
N/A	Flare Slope LT (%)	N/A	N/A	Flare Slope RT (%)	N/A
N/A	Flare Traversable LT?	N/A	N/A	Flare Traversable RT?	N/A
N/A	Landing Length (in)	N/A	N/A	DWS Provided?	N/A
N/A	Landing Width (in)	N/A	N/A	DWS Contrast?	N/A
N/A	Landing Slope (%)	N/A	N/A	DWS Length (in)	N/A
N/A	Landing X Slope (%)	N/A	N/A	DWS Full Width?	N/A
N/A	Landing Curb? (Y/N)	N/A	N/A	DWS Offset (in)	N/A
N/A	Shared Landing?	N/A			
N/A	Gutter Ponding?	N/A	N/A	Gutter Slope (%)	N/A
N/A	Gutter Lip Ht (in)	N/A	N/A	Gutter X Slope (%)	N/A
N/A	Painted X Walk1?	No	N/A	Painted X Walk2?	N/A
	X Walk 1 Direction	To NE		X Walk 2 Direction	N/A
N/A	X Walk 1 Width (in)	N/A	N/A	X Walk 2 Width (in)	N/A
	X Walk 1 Slope (%)	3.1		X Walk 2 Slope (%)	N/A
	X Walk 1 X Slope (%)	1.9		X Walk 2 X Slope (%)	N/A

N/A	Ramp inside XWalk1?	N/A	N/A	Ramp inside XWalk2?	N/A
	Road Slope (%)	N/A	N/A	Clear Space?	N/A
	Road X Slope (%)	N/A	N/A	Clear Space to XWalk (in)	N/A
N/A	Any Obstructions?	N/A	N/A	Storm Grate/Utility Hazard?	N/A
	Obstruction Type			Storm Grate/Utility Type	
		N/A			N/A
			Yes	Surface Condition? (G/P)	Good

**Remove & Replace Entire Ramp.**

Total Cost: \$ 1850.00
