Access Compliance Report

Public Rights-of-Way (Curb Ramps)

Intersection ID: 20874	Main Street: STEELE_CREEK_RD	Cross Street: WESTINGHOUSE_COMMONS_DR	Location: NW
ADA ID: 0C57CA018166	Ramp Type: Directional1	Initial Pass/Fail: Fail	Overall Compliance: No
		Severity Score: 1.25

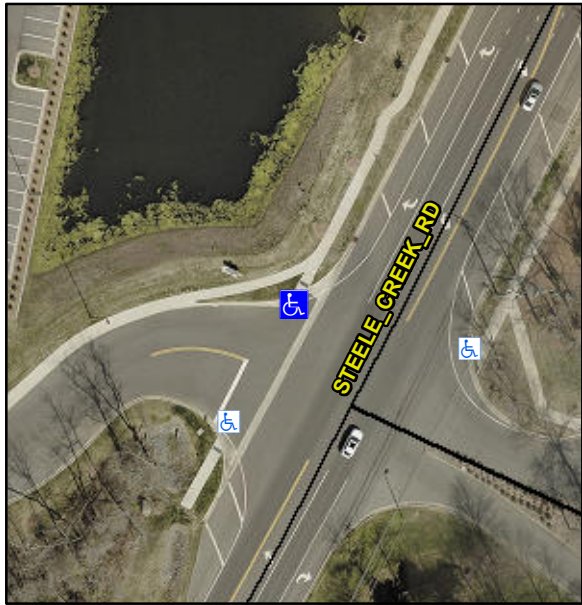
Possible Solutions:		Compliance	Description	Data	Compliance	Description	Data
	Remove & Replace Entire Ramp.		N/A	Ramp Length (in)	80.0	N/A	Grade Break?	N/A
			Yes	Ramp Width (in)	60.0	N/A	Grade Break Slope (%)	0.0
			Yes	Ramp Slope (%)	3.1	N/A	Grade Break XSlope (%)	0.0
			No	Ramp XSlope (%)	4.1			
			N/A	Flare Type LT	N/A	N/A	Flare Type RT	N/A
			N/A	Flare Slope LT (%)	N/A	N/A	Flare Slope RT (%)	0.0
			N/A	Flare Traversable LT?	N/A	N/A	Flare Traversable RT?	N/A
	Surveyor Notes:		N/A	Landing Length (in)	0.0	N/A	DWS Provided?	N/A
	N/A		N/A	Landing Width (in)	0.0	N/A	DWS Contrast?	N/A
		N/A	Landing Slope (%)	0.0	N/A	DWS Length (in)	N/A	
		N/A	Landing X Slope (%)	0.0	N/A	DWS Full Width?	N/A	
PROW/ADA:		N/A	Landing Curb? (Y/N)	N/A	N/A	DWS Offset LT (in)	N/A	
R304.5.3		N/A	Shared Landing?	N/A	N/A	DWS Offset RT (in)	N/A

N/A	Gutter Ponding?	0.0	N/A	Gutter Slope (%)	N/A	
		N/A	Gutter Lip Ht (in)	0.0	N/A	Gutter X Slope (%)	N/A	
		N/A	Painted X Walk1?	No		Road Slope (%)	1.2	
			X Walk 1 Direction	To SW		Road X Slope (%)	2.8	
			X Walk 1 Width (in)	N/A		Clear Space?	N/A	
			X Walk 1 Slope (%)	1.2	N/A	Clear Space to XWalk (in)	N/A	
			X Walk 1 X Slope (%)	2.8	N/A	Storm Grate/Utility Hazard?	N/A	
		N/A	Ramp inside XWalk1?	N/A		Storm Grate/Utility Type		
		N/A	Any Obstructions?	N/A			N/A	
			Obstruction Type		Yes	Surface Condition? (G/P)	Good	
					N/A	Curb Slope (%)	2.0	
Total Cost:		\$ 1600.00						
Street 1 Name		ENTRANCE						
Stop Condition-Street 1		StopSign						
Street 2 Name		N/A						
Stop Condition-Street 2		N/A
