Access Compliance Report

Public Rights-of-Way

(Curb Ramps)

Intersection ID: 8637	Main Street: STATESVILLE_AV	Cross Street: SAMUEL_ST	Location: SW
ADA ID: 0C5A7323FC9B	Ramp Type: Perp	Initial Pass/Fail: Fail	Overall Compliance: No
		Severity Score: 30

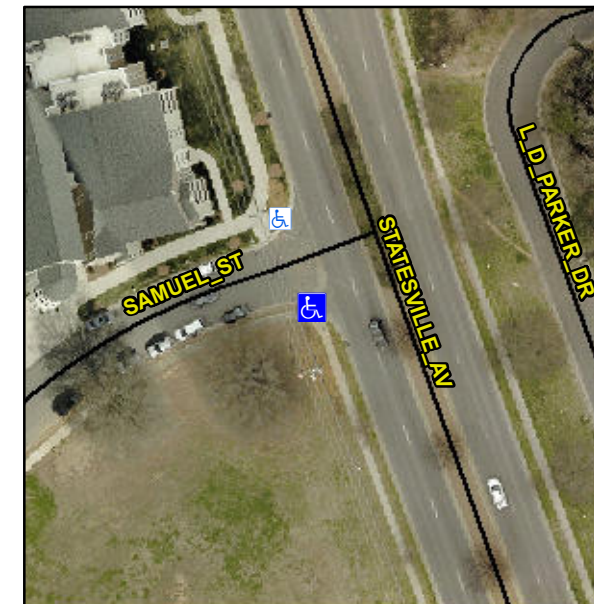
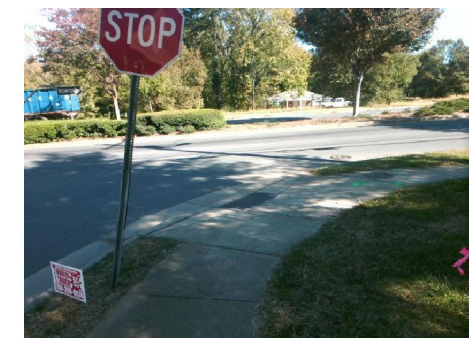
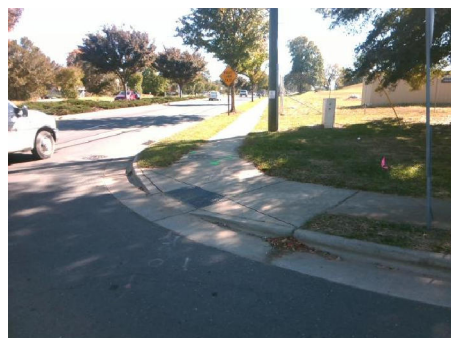
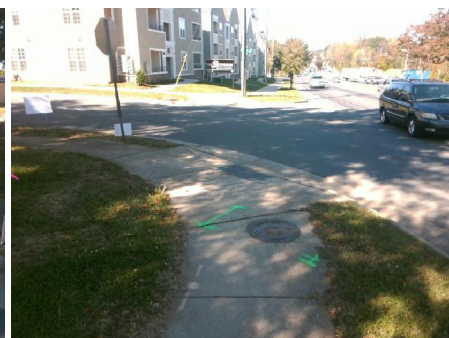
Not Found, R304.5.1, R304.2.2

Compliance	Description	Data	Compliance	Description	Data
N/A	Ramp Length (in)	93.0	No	Ramp Slope (%)	9.6
No	Ramp Width (in)	33.0	Yes	Ramp XSlope (%)	0.7
N/A	Flare Type LT	N/A	N/A	Flare Type RT	N/A
N/A	Flare Slope LT (%)	N/A	N/A	Flare Slope RT (%)	N/A
N/A	Flare Traversable LT?	N/A	N/A	Flare Traversable RT?	N/A
N/A	Landing Length (in)	N/A	N/A	DWS Provided?	N/A
N/A	Landing Width (in)	N/A	N/A	DWS Contrast?	N/A
N/A	Landing Slope (%)	N/A	N/A	DWS Length (in)	N/A
N/A	Landing X Slope (%)	N/A	N/A	DWS Full Width?	N/A
N/A	Landing Curb? (Y/N)	N/A	N/A	DWS Offset (in)	N/A
N/A	Shared Landing?	N/A			
N/A	Gutter Ponding?	N/A	N/A	Gutter Slope (%)	N/A
N/A	Gutter Lip Ht (in)	N/A	N/A	Gutter X Slope (%)	N/A
N/A	Painted X Walk1?	No	N/A	Painted X Walk2?	N/A
	X Walk 1 Direction	To N		X Walk 2 Direction	N/A
N/A	X Walk 1 Width (in)	N/A	N/A	X Walk 2 Width (in)	N/A
	X Walk 1 Slope (%)	2.0		X Walk 2 Slope (%)	N/A
	X Walk 1 X Slope (%)	3.2		X Walk 2 X Slope (%)	N/A

N/A	Ramp inside XWalk1?	N/A	N/A	Ramp inside XWalk2?	N/A
	Road Slope (%)	N/A	N/A	Clear Space?	N/A
	Road X Slope (%)	N/A	N/A	Clear Space to XWalk (in)	N/A
N/A	Any Obstructions?	N/A	N/A	Storm Grate/Utility Hazard?	N/A
	Obstruction Type			Storm Grate/Utility Type	
		N/A			N/A
			Yes	Surface Condition? (G/P)	Good

Remove & Replace Entire Ramp.

\$ 1850.00
