Access Compliance Report Public Rights-of-Way (Curb Ramps)

Intersection ID: 12385 Main Street: PAMLICO_ST Cross Street: N/A Location: N

ADA ID: 0C606DB7FDC6 Ramp Type: Perp Initial Pass/Fail: Fail Overall Compliance: No Severity Score: 8.75

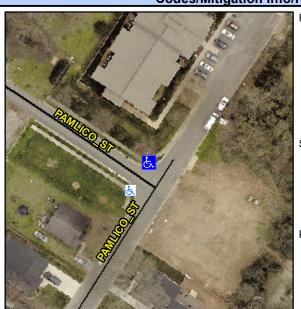
PROW/ADA:
NOT Found, R304.5.1

Field Measurements/Component Compliance					
Compliance Description		Data	Comp	liance Description	Data
N/A	Ramp Length (in)	48.0	Yes	Ramp Slope (%)	5.8
No	Ramp Width (in)	36.5	Yes	Ramp XSlope (%)	1.6
N/A	Flare Type LT	N/A	N/A	Flare Type RT	N/A
N/A	Flare Slope LT (%)	N/A	N/A	Flare Slope RT (%)	N/A
N/A	Flare Traversable LT?	N/A	N/A	Flare Traversable RT?	N/A
N/A	Landing Length (in)	N/A	N/A	DWS Provided?	N/A
N/A	Landing Width (in)	N/A	N/A	DWS Contrast?	N/A
N/A	Landing Slope (%)	N/A	N/A	DWS Length (in)	N/A
N/A	Landing X Slope (%)	N/A	N/A	DWS Full Width?	N/A
N/A	Landing Curb? (Y/N)	N/A	N/A	DWS Offset (in)	N/A
N/A	Shared Landing?	N/A			
N/A	Gutter Ponding?	N/A	N/A	Gutter Slope (%)	N/A
N/A	Gutter Lip Ht (in)	N/A	N/A	Gutter X Slope (%)	N/A
N/A	Painted X Walk1?	No	N/A	Painted X Walk2?	N/A
	X Walk 1 Direction	To SW		X Walk 2 Direction	N/A
N/A	X Walk 1 Width (in)	N/A	N/A	X Walk 2 Width (in)	N/A
	X Walk 1 Slope (%)	3.0		X Walk 2 Slope (%)	N/A

X Walk 1 X Slope (%)	2.4		X Walk 2 X Slope (%)	N/A
N/A	Ramp inside XWalk1?	N/A	N/A	Ramp inside XWalk2?	N/A
	Road Slope (%)	N/A	N/A	Clear Space?	N/A
	Road X Slope (%)	N/A	N/A	Clear Space to XWalk (in)	N/A
N/A	Any Obstructions?	N/A	N/A	Storm Grate/Utility Hazard?	N/A
	Obstruction Type		l	Storm Grate/Utility Type	
		N/A			N/A
			Yes	Surface Condition? (G/P)	Good

Remove & Replace Entire Ramp.

Total Cost: \$ 1850.00
