Access Compliance Report

Public Rights-of-Way

(Curb Ramps)

Intersection ID: 8737	Main Street: BEATTIES_FORD_RD	Cross Street: ST_PAUL_ST	Location: SW
ADA ID: 0C65E0B60133	Ramp Type: PerpDiag	Initial Pass/Fail: Fail	Overall Compliance: No
Severity Score: 37.5			
Codes/Mitigation Info/Possible Solution		Field Measurements/Component Compliance

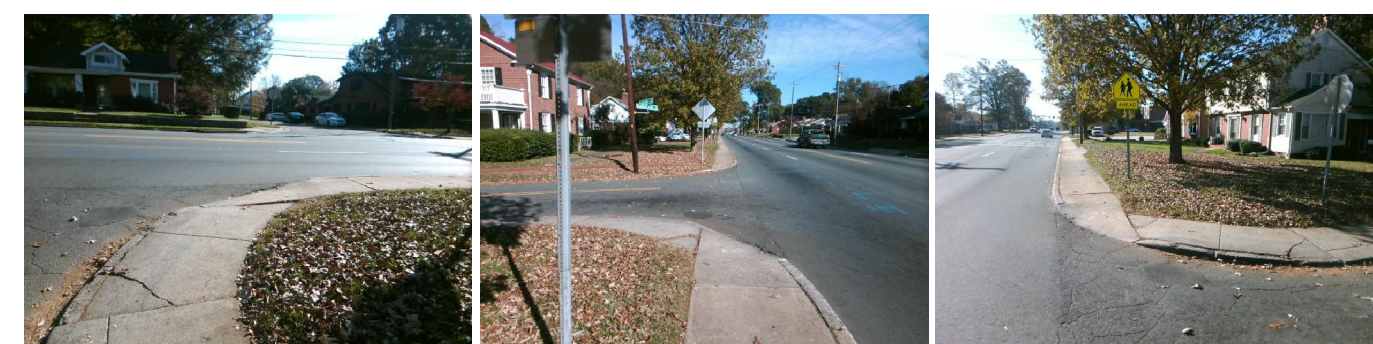
Possible Solutions:							
	Remove & Replace Curb Ramp With Two New Directional Ramps or Equivalent.							
	Surveyor Notes:							
	N/A							
	PROW/ADA:							
	R304.2.2, R304.5.3							
	Street 1 Name	BEATTIES FORD RD	Compliance	Description	Data	Compliance	Description	Data
	Stop Condition-Street 2	None	N/A	Ramp Length (in)	44.0	No	Ramp Slope (%)	10.6
	Street 2 Name	ESTELLE ST	Yes	Ramp Width (in)	60.0	No	Ramp XSlope (%)	9.4
	Stop Condition-Street 1	StopSign	N/A	Flare Type LT	N/A	N/A	Flare Type RT	N/A
		N/A	Flare Slope LT (%)	N/A	N/A	Flare Slope RT (%)	N/A	
		N/A	Flare Traversable LT?	N/A	N/A	Flare Traversable RT?	N/A	
		N/A	Landing Length (in)	N/A	N/A	DWS Provided?	N/A	
		N/A	Landing Width (in)	N/A	N/A	DWS Contrast?	N/A	
		N/A	Landing Slope (%)	N/A	N/A	DWS Length (in)	N/A	
		N/A	Landing X Slope (%)	N/A	N/A	DWS Full Width?	N/A	
		N/A	Landing Curb? (Y/N)	N/A	N/A	DWS Offset (in)	N/A	
		N/A	Shared Landing?	N/A

N/A	Gutter Ponding?	N/A	N/A	Gutter Slope (%)	N/A	
		N/A	Gutter Lip Ht (in)	N/A	N/A	Gutter X Slope (%)	N/A	
		N/A	Painted X Walk1?	No	N/A	Painted X Walk2?	No	
			X Walk 1 Direction	To E		X Walk 2 Direction	To N	
		N/A	X Walk 1 Width (in)	N/A	N/A	X Walk 2 Width (in)	N/A	
			X Walk 1 Slope (%)	6.7		X Walk 2 Slope (%)	2.4	
			X Walk 1 X Slope (%)	0.1		X Walk 2 X Slope (%)	3.6	
		N/A	Ramp inside XWalk1?	N/A	N/A	Ramp inside XWalk2?	N/A	
			Road Slope (%)	5.0	N/A	Clear Space?	N/A	
			Road X Slope (%)	5.6	N/A	Clear Space to XWalk (in)	N/A	
		N/A	Any Obstructions?	N/A	N/A	Storm Grate/Utility Hazard?	N/A	
			Obstruction Type			Storm Grate/Utility Type		
				N/A			N/A	
					Yes	Surface Condition? (G/P)	Good	
Total Cost:		\$	3200.00
