## **Access Compliance Report Public Rights-of-Way** (Curb Ramps)

Intersection ID: 12777 Main Street: HEATHERWOOD LN **Cross Street: PENCE RD** Location: SE ADA ID: 0C68DF4DF604 Ramp Type: BlendTrans1 Initial Pass/Fail: Fail **Overall Compliance: No Severity Score:**

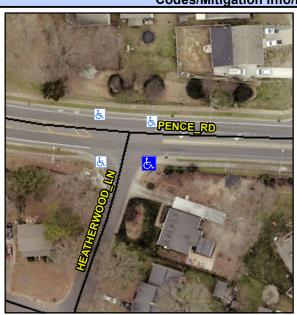
Fleid Measurements/Component Compliance						
	Compliance Description		Data	Compliance Description		Data
	N/A	Ramp Length (in)	61.0	Yes	BlendTrans Slope (%)	3.2
	No	Ramp Width (in)	40.0	Yes	BlendTrans XSlope (%)	0.0
	N/A	Flare Type LT	N/A	N/A	Flare Type RT	N/A
	N/A	Flare Slope LT (%)	N/A	N/A	Flare Slope RT (%)	N/A
	N/A	Flare Traversable LT?	N/A	N/A	Flare Traversable RT?	N/A
	N/A	Landing Length (in)	N/A	N/A	DWS Provided?	N/A
	N/A	Landing Width (in)	N/A	N/A	DWS Contrast?	N/A
	N/A	Landing Slope (%)	N/A	N/A	DWS Length (in)	N/A
	N/A	Landing X Slope (%)	N/A	N/A	DWS Full Width?	N/A
	N/A	Landing Curb? (Y/N)	N/A	N/A	DWS Offset (in)	N/A
	N/A	Shared Landing?	N/A			
	N/A	Gutter Ponding?	N/A	N/A	Gutter Slope (%)	N/A
	N/A	Gutter Lip Ht (in)	N/A	N/A	Gutter X Slope (%)	N/A
	N/A	Painted X Walk1?	No	N/A	Painted X Walk2?	No
		X Walk 1 Direction	To N		X Walk 2 Direction	To W
		X Walk 1 Width (in)	N/A		X Walk 2 Width (in)	N/A

X Walk 1 Slope (%)	3.9		X Walk 2 Slope (%)	4.8
		X Walk 1 X Slope (%)	3.3		X Walk 2 X Slope (%)	1.7
	N/A	Ramp inside XWalk1?	N/A	N/A	Ramp inside XWalk2?	N/A
		Road Slope (%)	3.5		Clear Space?	N/A
		Road X Slope (%)	4.2	N/A	Clear Space to XWalk (in)	N/A
	N/A	Any Obstructions?	N/A	N/A	Storm Grate/Utility Hazard?	N/A
		Obstruction Type			Storm Grate/Utility Type

**PENCE RD** None **HEATHERWOOD LN** StopSign Possible Solutions: Remove & Replace Curb Ramp With Two New Directional Ramps or Equivalent. Surveyor Notes: N/A PROW/ADA: Not Found, R304.5.1
