# Access Compliance Report

## Public Rights-of-Way

### (Curb Ramps)

Intersection ID: 18845	Main Street: HORTON_CT	Cross Street: SENECA_PL	Location: SW
ADA ID: 0C7FB5C625A8	Ramp Type: PerpDiag	Initial Pass/Fail: Fail	Overall Compliance: No
		Severity Score: 10

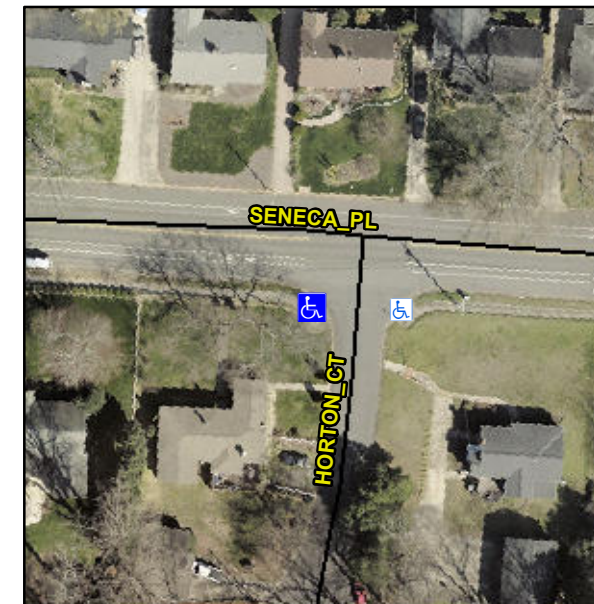
**Not Found, R304.5.1, R304.5.3**

Compliance	Description	Data	Compliance	Description	Data
N/A	Ramp Length (in)	48.0	Yes	Ramp Slope (%)	6.0
No	Ramp Width (in)	46.5	No	Ramp XSlope (%)	3.1
N/A	Flare Type LT	N/A	N/A	Flare Type RT	N/A
N/A	Flare Slope LT (%)	N/A	N/A	Flare Slope RT (%)	N/A
N/A	Flare Traversable LT?	N/A	N/A	Flare Traversable RT?	N/A
N/A	Landing Length (in)	N/A	N/A	DWS Provided?	N/A
N/A	Landing Width (in)	N/A	N/A	DWS Contrast?	N/A
N/A	Landing Slope (%)	N/A	N/A	DWS Length (in)	N/A
N/A	Landing X Slope (%)	N/A	N/A	DWS Full Width?	N/A
N/A	Landing Curb? (Y/N)	N/A	N/A	DWS Offset (in)	N/A
N/A	Shared Landing?	N/A			
N/A	Gutter Ponding?	N/A	N/A	Gutter Slope (%)	N/A
N/A	Gutter Lip Ht (in)	N/A	N/A	Gutter X Slope (%)	N/A
N/A	Painted X Walk1?	No	N/A	Painted X Walk2?	No
	X Walk 1 Direction	To E		X Walk 2 Direction	To N
N/A	X Walk 1 Width (in)	N/A	N/A	X Walk 2 Width (in)	N/A
	X Walk 1 Slope (%)	1.6		X Walk 2 Slope (%)	2.2
	X Walk 1 X Slope (%)	4.1		X Walk 2 X Slope (%)	0.2

N/A	Ramp inside XWalk1?	N/A	N/A	Ramp inside XWalk2?	N/A
	Road Slope (%)	1.5	N/A	Clear Space?	N/A
	Road X Slope (%)	7.4	N/A	Clear Space to XWalk (in)	N/A
N/A	Any Obstructions?	N/A	N/A	Storm Grate/Utility Hazard?	N/A
	Obstruction Type			Storm Grate/Utility Type	
		N/A			N/A
			Yes	Surface Condition? (G/P)	Good

**Remove & Replace Curb Ramp With Two New Directional Ramps or Equivalent.**

Total Cost: \$ 3200.00
