Access Compliance Report

Public Rights-of-Way

(Curb Ramps)

Intersection ID: 46684	Main Street: ABODE_LILY_LN	Cross Street: JEWELFLOWER_RD	Location: NE
ADA ID: 0C88AA410E5D	Ramp Type: PerpDiag	Initial Pass/Fail: Fail	Overall Compliance: No
Severity Score: 13.75			
Codes/Mitigation Info/Possible Solution		Field Measurements/Component Compliance

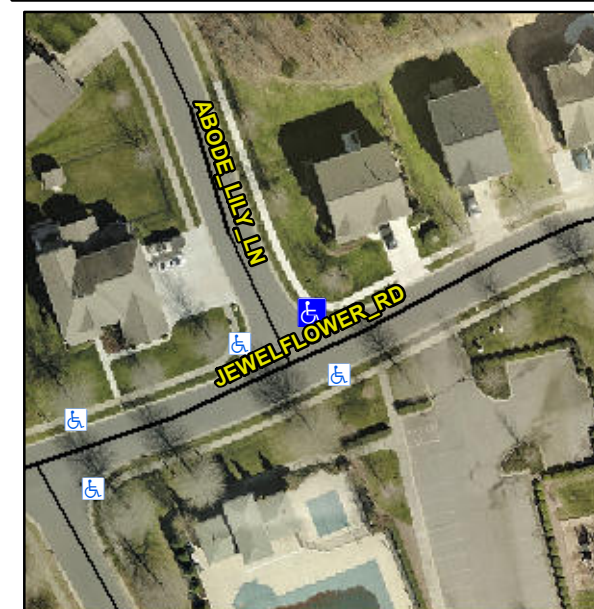
Not Found, R304.2.2, R304.5.3

Compliance	Description	Data	Compliance	Description	Data
N/A	Ramp Length (in)	47.5	No	Ramp Slope (%)	9.2
Yes	Ramp Width (in)	48.0	No	Ramp XSlope (%)	2.5
N/A	Flare Type LT	N/A	N/A	Flare Type RT	N/A
N/A	Flare Slope LT (%)	N/A	N/A	Flare Slope RT (%)	N/A
N/A	Flare Traversable LT?	N/A	N/A	Flare Traversable RT?	N/A
N/A	Landing Length (in)	N/A	N/A	DWS Provided?	N/A
N/A	Landing Width (in)	N/A	N/A	DWS Contrast?	N/A
N/A	Landing Slope (%)	N/A	N/A	DWS Length (in)	N/A
N/A	Landing X Slope (%)	N/A	N/A	DWS Full Width?	N/A
N/A	Landing Curb? (Y/N)	N/A	N/A	DWS Offset (in)	N/A
N/A	Shared Landing?	N/A			
N/A	Gutter Ponding?	N/A	N/A	Gutter Slope (%)	N/A
N/A	Gutter Lip Ht (in)	N/A	N/A	Gutter X Slope (%)	N/A
N/A	Painted X Walk1?	No	N/A	Painted X Walk2?	No
	X Walk 1 Direction	To W		X Walk 2 Direction	To S
N/A	X Walk 1 Width (in)	N/A	N/A	X Walk 2 Width (in)	N/A
	X Walk 1 Slope (%)	2.1		X Walk 2 Slope (%)	1.1
	X Walk 1 X Slope (%)	0.7		X Walk 2 X Slope (%)	0.9

N/A	Ramp inside XWalk1?	N/A	N/A	Ramp inside XWalk2?	N/A
	Road Slope (%)	3.1	N/A	Clear Space?	N/A
	Road X Slope (%)	1.6	N/A	Clear Space to XWalk (in)	N/A
N/A	Any Obstructions?	N/A	N/A	Storm Grate/Utility Hazard?	N/A
	Obstruction Type			Storm Grate/Utility Type	
		N/A			N/A
		Yes		Surface Condition? (G/P)	Good

Possible Solutions:

Remove & Replace Curb Ramp With Two New Directional Ramps or Equivalent.
