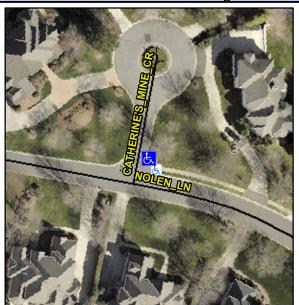
Intersection ID: 27660Main Street:CATHERINE'S_MINE_CRCross Street:NOLEN_LNLocation:NEADA ID: 0C92AE093566Ramp Type:PerpInitial Pass/Fail:FailOverall Compliance:No...Severity Score:37.5

ass/F	ali: Fali Overali	Compilar	ce: N	o Severity Score:	37.
	Field Measure	ements/C	ompo	nent Compliance	
Comp	liance Description	Data	Comp	liance Description	Data
N/A	Ramp Length (in)	94.0	No	Ramp Slope (%)	13.8
Yes	Ramp Width (in)	48.0	No	Ramp XSlope (%)	6.8
N/A	Flare Type LT	N/A	N/A	Flare Type RT	N/A
N/A	Flare Slope LT (%)	N/A	N/A	Flare Slope RT (%)	N/A
N/A	Flare Traversable LT?	N/A	N/A	Flare Traversable RT?	N/A
N/A	Landing Length (in)	N/A	N/A	DWS Provided?	N/A
N/A	Landing Width (in)	N/A	N/A	DWS Contrast?	N/A
N/A	Landing Slope (%)	N/A	N/A	DWS Length (in)	N/A
N/A	Landing X Slope (%)	N/A	N/A	DWS Full Width?	N/A
N/A	Landing Curb? (Y/N)	N/A	N/A	DWS Offset (in)	N/A
N/A	Shared Landing?	N/A			
N/A	Gutter Ponding?	N/A	N/A	Gutter Slope (%)	N/A
N/A	Gutter Lip Ht (in)	N/A	N/A	Gutter X Slope (%)	N/A
N/A	Painted X Walk1?	No	N/A	Painted X Walk2?	N/A
	X Walk 1 Direction	To NW		X Walk 2 Direction	N/A
N/A	X Walk 1 Width (in)	N/A	N/A	X Walk 2 Width (in)	N/A

X Walk 1 Slope (%)	1.1		X Walk 2 Slope (%)	N/A
	X Walk 1 X Slope (%)	3.6		X Walk 2 X Slope (%)	N/A
N/A	Ramp inside XWalk1?	N/A	N/A	Ramp inside XWalk2?	N/A
	Road Slope (%)	N/A	N/A	Clear Space?	N/A
	Road X Slope (%)	N/A	N/A	Clear Space to XWalk (in)	N/A
N/A	Any Obstructions?	N/A	N/A	Storm Grate/Utility Hazard?	N/A
	Obstruction Type			Storm Grate/Utility Type	
		N/A			N/A
			Yes	Surface Condition? (G/P)	Good

Possible Solutions:	<u>c</u>		
Remove & Replace Entire Ramp.	N		
	Υ		
	N		
	N		
	N		
	N		
Surveyor Notes:	N		
N/A	N		
	N		
	N		
	N		
PROW/ADA:	N		
Not Found, R304.2.2, R304.5.3			
	N		
	N		
	N
