Access Compliance Report

Public Rights-of-Way

(Curb Ramps)

| Intersection ID: 11452 | Main Street: E_16TH_ST | Cross Street: PARKWOOD_AV | Location: N |

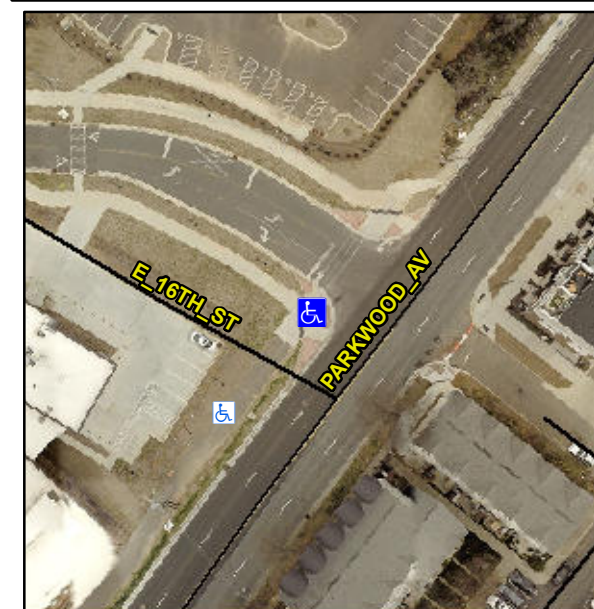
| ADA ID: 0C97123564D2 | Ramp Type: Perp | Initial Pass/Fail: Fail | Overall Compliance: No |
| Severity Score: 8.75 | | | |

Not Found, R304.5.1

| Compliance | Description | Data | Compliance | Description | Data |
|---|---|---|---|---|---|
| No | Ramp Width (in) | 42.0 | Yes | Ramp XSlope (%) | 1.0 |

Possible Solutions:

Remove & Replace Entire Ramp.

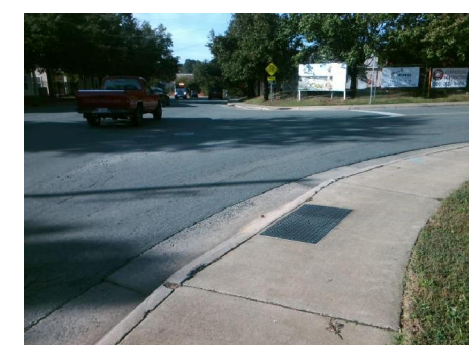
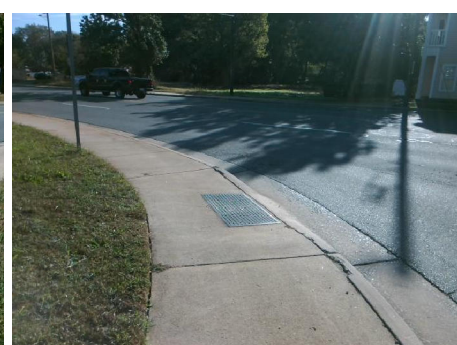
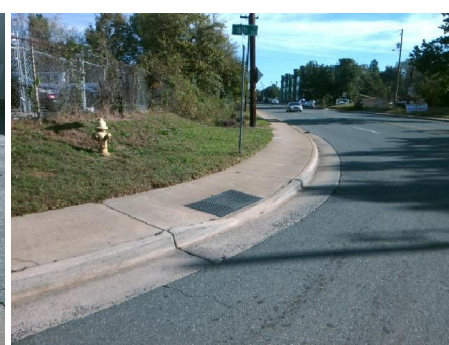
| Compliance | Description | Data | Compliance | Description | Data |
|---|---|---|---|---|---|
| N/A | Ramp Length (in) | 60.5 | Yes | Ramp Slope (%) | 7.2 |
| | | | Yes | Surface Condition? (G/P) | Good |
