# Access Compliance Report

## Public Rights-of-Way

### (Curb Ramps)

| Intersection ID: 27452 | Main Street: BALLANTYNE_COMMONS_PY | Cross Street: BALLANTYNE_CORPORATE_PL | Location: SE |

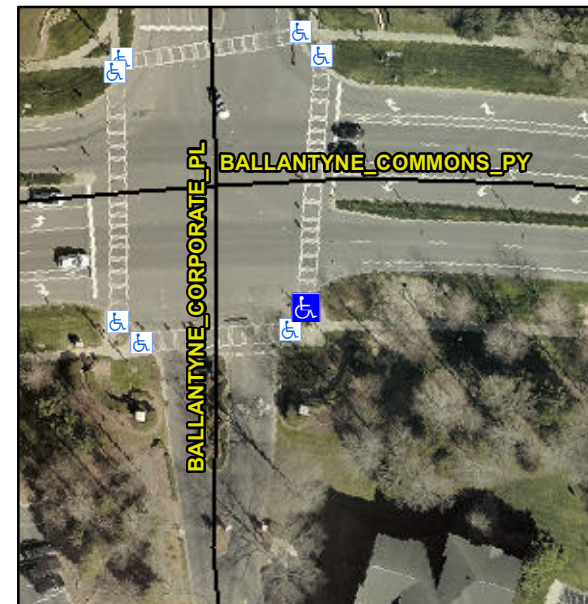
**Not Found, R304.5.1, R304.2.2**

| Compliance | Description | Data | Compliance | Description | Data |
|---|---|---|---|---|---|
| N/A | Ramp Length (in) | 134.0 | No | Ramp Slope (%) | 13.3 |
| No | Ramp Width (in) | 34.0 | Yes | Ramp XSlope (%) | 2.0 |

**Remove & Replace Entire Ramp.**

Total Cost: \$ 1850.00
