Access Compliance Report Public Rights-of-Way (Curb Ramps)

Intersection ID: 27355 Main Street: JOHNSTON RD Cross Street: BRIXHAM HILL AV Location: SW **Overall Compliance: No** ADA ID: 0CA767D4D2BC Ramp Type: Perp Initial Pass/Fail: Fail **Severity Score:** 25

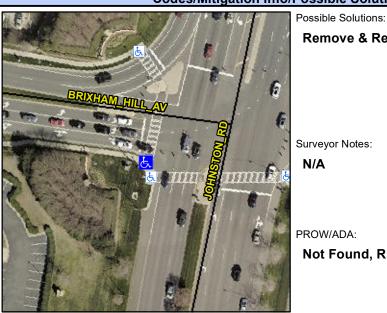
48.0 No

26.0 No

Remove & Replace Entire Ramp.	N/A
•	Yes
	N/A
	N/A
	N/A
	N/A
Surveyor Notes:	N/A
N/A	N/A
	N/A
	N/A
	N/A
PROW/ADA:	N/A
Not Found, R304.2.2, R304.5.3	N/A
, ,	N/A
	N/A
	N/A
