Access Compliance Report

Public Rights-of-Way

(Curb Ramps)

| Intersection ID: 10027080 | Main Street: GALLERIA_BV | Cross Street: N/A | Location: SE |

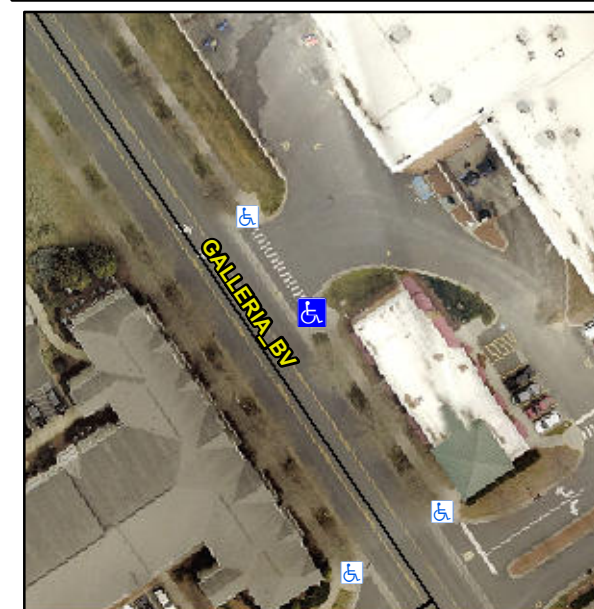
Not Found, R304.5.1, R304.5.3

| Compliance | Description | Data | Compliance | Description | Data |
|---|---|---|---|---|---|
| N/A | Ramp Length (in) | 96.0 | Yes | Ramp Slope (%) | 6.6 |
| No | Ramp Width (in) | 41.0 | No | Ramp XSlope (%) | 6.4 |

Remove & Replace Curb Ramp With Two New Directional Ramps or Equivalent.
