Access Compliance Report

Public Rights-of-Way (Curb Ramps)

Intersection ID: 7448	Main Street: ROCKY_RIVER_RD	Cross Street: GRIER_RD	Location: NW
ADA ID: 0CC76DB84B78	Ramp Type: Para	Initial Pass/Fail: Fail	Overall Compliance: No
		Severity Score: 12.5

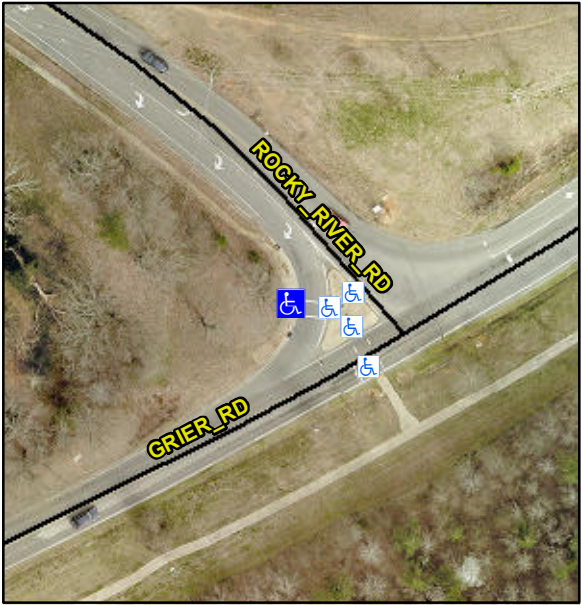
Possible Solutions:		Compliance	Description	Data
	Remove & Replace Entire Ramp.		Compliance	Description	Data
			N/A	Ramp Length LT (in)	70.0
			Yes	Ramp Width LT (in)	70.0
			Yes	Ramp Slope LT (%)	3.5
			No	Ramp XSlope LT (%)	6.2
			N/A	Landing Length (in)	N/A
			N/A	Landing Width (in)	N/A
			N/A	Landing Slope (%)	N/A
			N/A	Landing X Slope (%)	N/A
<p>Surveyor Notes:</p> <p>LT & RT RP SL < 5%, DAMAGED DWS</p> <p>PROW/ADA:</p> <p>Not Found, R304.5.3</p>			N/A	Ramp Length RT (in)	57.0
			Yes	Ramp Width RT (in)	64.0
			Yes	Ramp Slope RT (%)	4.2
			No	Ramp XSlope RT (%)	5.6
			N/A	DWS Provided?	N/A
			N/A	DWS Contrast?	N/A
			N/A	DWS Length (in)	N/A
			N/A	DWS Full Width?	N/A
			N/A	DWS Offset (in)	N/A
			N/A	Shared Landing?	N/A
			N/A	Gutter Ponding?	N/A
			N/A	Gutter Lip Ht (in)	N/A
			N/A	Painted X Walk1?	Yes
				X Walk 1 Direction	To E

N/A	X Walk 1 Width (in)	85.5
				X Walk 1 Slope (%)	0.3
				X Walk 1 X Slope (%)	0.9
			N/A	Ramp inside XWalk1?	Yes
			N/A	Road Slope (%)	N/A
			N/A	Road X Slope (%)	N/A
			N/A	Any Obstructions?	N/A
				Obstruction Type	
<p>Total Cost:</p> <p>\$ 1600.00</p>			N/A		N/A
			Yes	Surface Condition? (G/P)	Good
			Replace	Curb Slope (%)	16.5
