Access Compliance Report

Public Rights-of-Way

(Curb Ramps)

| Intersection ID: 42783 | Main Street: OLD_STONE_CROSSING_DR | Cross Street: SAWMILL_TRACE_DR | Location: NE |

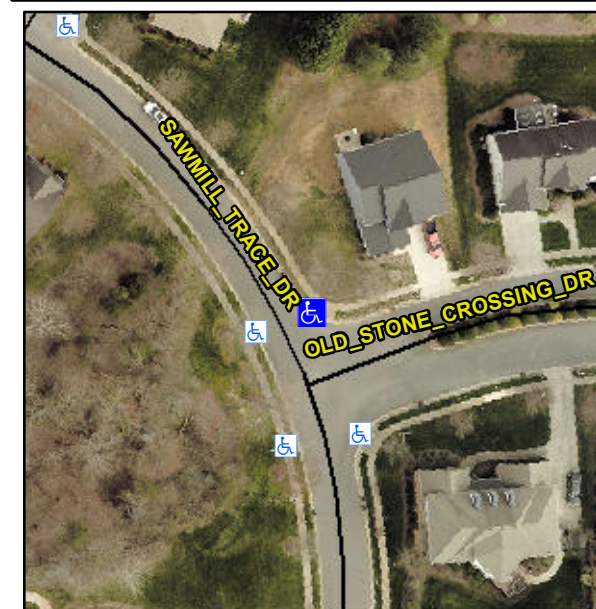
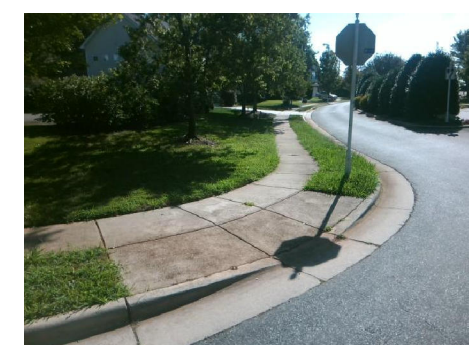
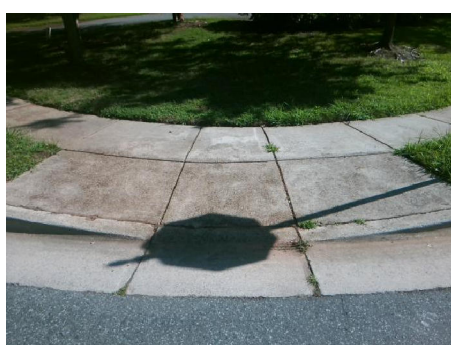
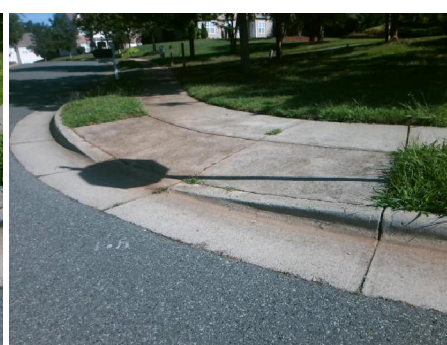
| ADA ID: 0CD19912EC2B | Ramp Type: PerpDiag | Initial Pass/Fail: Fail | Overall Compliance: No |
| Severity Score: 33.75 | | | |

Not Found, R304.5.1, R304.2.2

| Compliance | Description | Data | Compliance | Description | Data |
|---|---|---|---|---|---|
| N/A | Ramp Length (in) | 42.5 | No | Ramp Slope (%) | 12.5 |
| No | Ramp Width (in) | 39.5 | Yes | Ramp XSlope (%) | 0.4 |

Remove & Replace Curb Ramp With Two New Directional Ramps or Equivalent.
