Intersection ID: 20811	Main Street: EDGEWATER_DR	Cross Street: SOUTH_BV	Location:	SE
ADA ID: 0CE03B8DD090	Ramp Type: PerpDiag	Initial Pass/Fail: Fail	Overall Compliance: No	Severity Score: 18.75

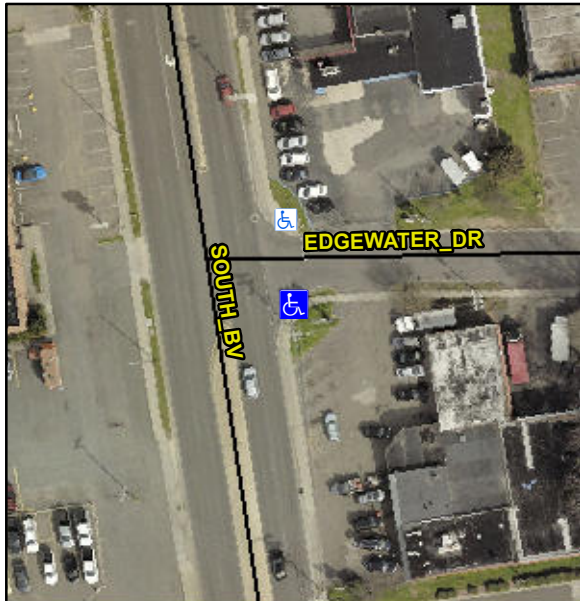
Possible Solutions:		Compliance	Description	Data	Compliance	Description	Data
	Remove & Replace Curb Ramp With Two New Directional Ramps or Equivalent.		N/A	Ramp Length (in)	60.0	Yes	Ramp Slope (%)	7.5
			No	Ramp Width (in)	33.0	No	Ramp XSlope (%)	4.5
			N/A	Flare Type LT	N/A	N/A	Flare Type RT	N/A
	Surveyor Notes: N/A		N/A	Flare Slope LT (%)	N/A	N/A	Flare Slope RT (%)	N/A
			N/A	Flare Traversable LT?	N/A	N/A	Flare Traversable RT?	N/A
			N/A	Landing Length (in)	N/A	N/A	DWS Provided?	N/A
			N/A	Landing Width (in)	N/A	N/A	DWS Contrast?	N/A
			N/A	Landing Slope (%)	N/A	N/A	DWS Length (in)	N/A
			N/A	Landing X Slope (%)	N/A	N/A	DWS Full Width?	N/A
PROW/ADA: Not Found, R304.5.1, R304.5.3		N/A	Landing Curb? (Y/N)	N/A	N/A	DWS Offset (in)	N/A	
		N/A	Shared Landing?	N/A				
		N/A	Gutter Ponding?	N/A	N/A	Gutter Slope (%)	N/A

N/A	Gutter Lip Ht (in)	N/A	N/A	Gutter X Slope (%)	N/A	
		N/A	Painted X Walk1?	No	N/A	Painted X Walk2?	No	
			X Walk 1 Direction	To N		X Walk 2 Direction	To W	
		N/A	X Walk 1 Width (in)	N/A	N/A	X Walk 2 Width (in)	N/A	
			X Walk 1 Slope (%)	1.9		X Walk 2 Slope (%)	8.1	
			X Walk 1 X Slope (%)	8.4		X Walk 2 X Slope (%)	1.0	
		N/A	Ramp inside XWalk1?	N/A	N/A	Ramp inside XWalk2?	N/A	
Total Cost: \$ 3200.00			Road Slope (%)	5.6	N/A	Clear Space?	N/A	
			Road X Slope (%)	9.0	N/A	Clear Space to XWalk (in)	N/A	
		N/A	Any Obstructions?	N/A	N/A	Storm Grate/Utility Hazard?	N/A	
			Obstruction Type			Storm Grate/Utility Type		
				N/A			N/A	
					Yes	Surface Condition? (G/P)	Good
