Access Compliance Report Public Rights-of-Way (Curb Ramps)

Intersection ID: 14639 Main Street: ORCHARD_RIDGE_DR Cross Street: SPLIT_RAIL_LN Location: SE

ADA ID: 0CE110C9C644 Ramp Type: Perp Initial Pass/Fail: Fail Overall Compliance: No Severity Score: 12.5

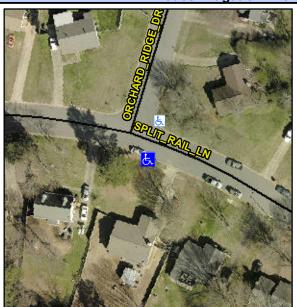
a55/F	ali. Fali Overali	Compilan	ice. IN	o Severity Score.	12.			
Field Measurements/Component Compliance								
Comp	oliance Description	Data	Comp	liance Description	Data			
N/A	Ramp Length (in)	50.0	No	Ramp Slope (%)	10.2			
Yes	Ramp Width (in)	50.0	Yes	Ramp XSlope (%)	0.5			
N/A	Flare Type LT	N/A	N/A	Flare Type RT	N/A			
N/A	Flare Slope LT (%)	N/A	N/A	Flare Slope RT (%)	N/A			
N/A	Flare Traversable LT?	N/A	N/A	Flare Traversable RT?	N/A			
N/A	Landing Length (in)	N/A	N/A	DWS Provided?	N/A			
N/A	Landing Width (in)	N/A	N/A	DWS Contrast?	N/A			
N/A	Landing Slope (%)	N/A	N/A	DWS Length (in)	N/A			
N/A	Landing X Slope (%)	N/A	N/A	DWS Full Width?	N/A			
N/A	Landing Curb? (Y/N)	N/A	N/A	DWS Offset (in)	N/A			
N/A	Shared Landing?	N/A						
N/A	Gutter Ponding?	N/A	N/A	Gutter Slope (%)	N/A			
N/A	Gutter Lip Ht (in)	N/A	N/A	Gutter X Slope (%)	N/A			
N/A	Painted X Walk1?	No	N/A	Painted X Walk2?	N/A			
	X Walk 1 Direction	To NE		X Walk 2 Direction	N/A

N/A	X Walk 1 Width (in)	N/A	N/A	X Walk 2 Width (in)	N/A			
	X Walk 1 Slope (%)	7.5		X Walk 2 Slope (%)	N/A			
	X Walk 1 X Slope (%)	0.8		X Walk 2 X Slope (%)	N/A			
N/A	Ramp inside XWalk1?	N/A	N/A	Ramp inside XWalk2?	N/A			
	Road Slope (%)	N/A	N/A	Clear Space?	N/A			
	Road X Slope (%)	N/A	N/A	Clear Space to XWalk (in)	N/A			
N/A	Any Obstructions?	N/A	N/A	Storm Grate/Utility Hazard?	N/A			
	Obstruction Type			Storm Grate/Utility Type				
		N/A			N/A			
			Yes	Surface Condition? (G/P)	Good

OSSIDIE SOIGHOII	
Possible Solutions:	Cor
Remove & Replace Entire Ramp.	N/A
·	Yes
	N/A
	N/A
	N/A
	N/A
Surveyor Notes:	N/A
N/A	N/A
	N/A
	N/A
	N/A
PROW/ADA:	N/A
Not Found, R304.2.2	N/A
•	N/A
	N/A
	N/A
