# Access Compliance Report

## Public Rights-of-Way

### (Curb Ramps)

Intersection ID: 23574	Main Street: CARMEL_RD	Cross Street: QUAIL_HOLLOW_RD	Location: W
ADA ID: 0CF7E6D84816	Ramp Type: Perp	Initial Pass/Fail: Fail	Overall Compliance: No
Severity Score: 33.75			
Codes/Mitigation Info/Possible Solution		Field Measurements/Component Compliance

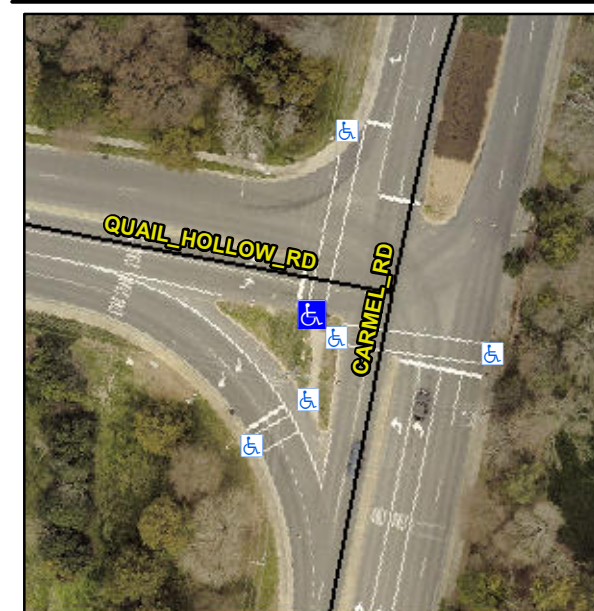
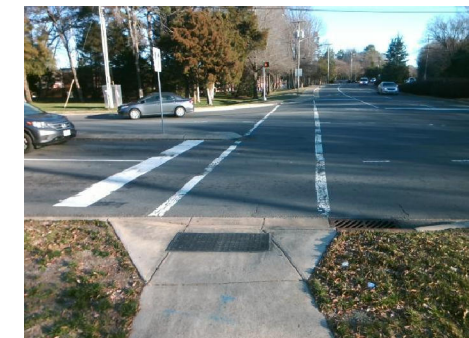
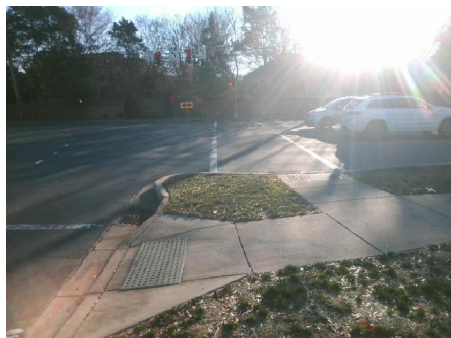
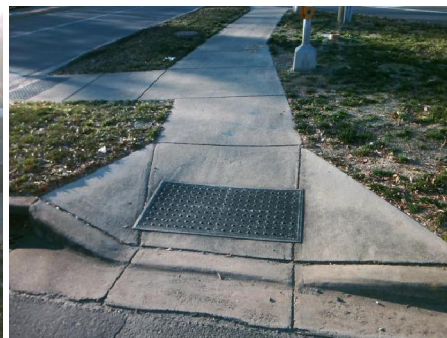
**R304.5.1, R304.2.2, R304.5.3**

Compliance	Description	Data	Compliance	Description	Data
N/A	Ramp Length (in)	58.0	No	Ramp Slope (%)	8.5
No	Ramp Width (in)	41.0	No	Ramp XSlope (%)	6.8
N/A	Flare Type LT	N/A	N/A	Flare Type RT	N/A
N/A	Flare Slope LT (%)	N/A	N/A	Flare Slope RT (%)	N/A
N/A	Flare Traversable LT?	N/A	N/A	Flare Traversable RT?	N/A
N/A	Landing Length (in)	N/A	N/A	DWS Provided?	N/A
N/A	Landing Width (in)	N/A	N/A	DWS Contrast?	N/A
N/A	Landing Slope (%)	N/A	N/A	DWS Length (in)	N/A
N/A	Landing X Slope (%)	N/A	N/A	DWS Full Width?	N/A
N/A	Landing Curb? (Y/N)	N/A	N/A	DWS Offset (in)	N/A
N/A	Shared Landing?	N/A			
N/A	Gutter Ponding?	N/A	N/A	Gutter Slope (%)	N/A
N/A	Gutter Lip Ht (in)	N/A	N/A	Gutter X Slope (%)	N/A
N/A	Painted X Walk1?	Yes	N/A	Painted X Walk2?	N/A
	X Walk 1 Direction	To N		X Walk 2 Direction	N/A
N/A	X Walk 1 Width (in)	94.0	N/A	X Walk 2 Width (in)	N/A
	X Walk 1 Slope (%)	1.5		X Walk 2 Slope (%)	N/A
	X Walk 1 X Slope (%)	1.2		X Walk 2 X Slope (%)	N/A

N/A	Ramp inside XWalk1?	Yes	N/A	Ramp inside XWalk2?	N/A
	Road Slope (%)	N/A	N/A	Clear Space?	N/A
	Road X Slope (%)	N/A	N/A	Clear Space to XWalk (in)	N/A
N/A	Any Obstructions?	N/A	N/A	Storm Grate/Utility Hazard?	N/A
	Obstruction Type			Storm Grate/Utility Type	
			N/A		N/A
			Yes	Surface Condition? (G/P)	Good

**Remove & Replace Entire Ramp.**

Total Cost: \$ 1850.00
