# Access Compliance Report

## Public Rights-of-Way

### (Curb Ramps)

| Intersection ID: 5674 | Main Street: HAMILTON_CR | Cross Street: JOHOY_DR | Location: NW |

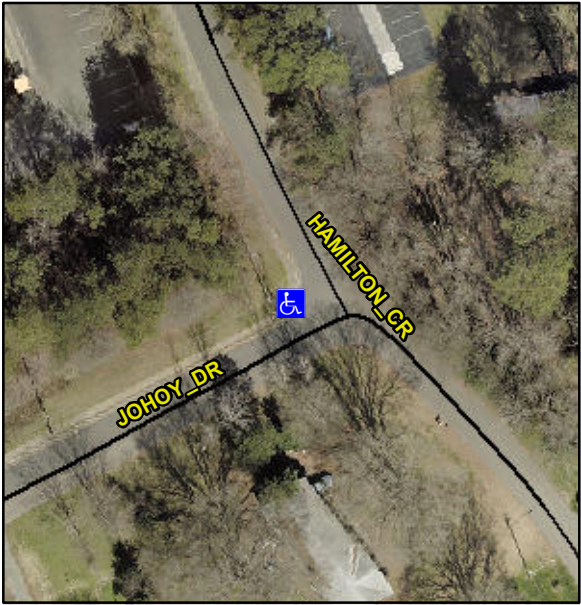
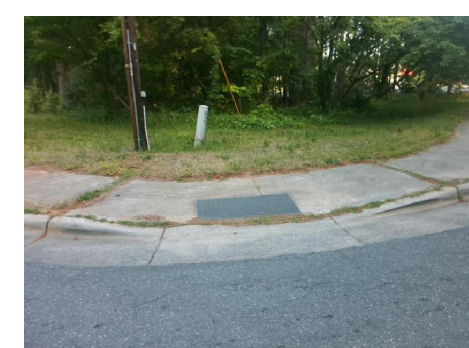
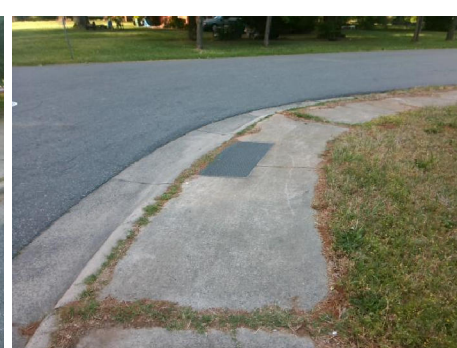
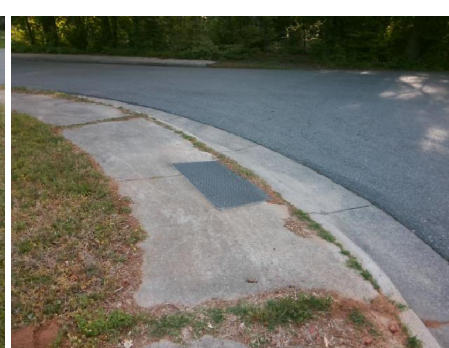
| ADA ID: 0D0567EE2929 | Ramp Type: Perp | Initial Pass/Fail: Fail | Overall Compliance: No |

| Codes/Mitigation Info/Possible Solution | | | Field Measurements/Component Compliance | | |
|---|---|--|---|---|---|
| | <b>Remove &amp; Replace Entire Ramp.</b> | | <b>No</b> | Ramp Length (in) | <b>60.0</b> |
| <p>Surveyor Notes:</p> <p><b>N/A</b></p> <p>PROW/ADA:</p> <p><b>Not Found, R304.2.2, R304.5.3</b></p> | | | <b>N/A</b> | Flare Type RT | <b>N/A</b> |

| Codes/Mitigation Info/Possible Solution | | | Field Measurements/Component Compliance | | |
|---|---|--|---|---|---|
| | Possible Solutions: | | <b>Compliance</b> | <b>Description</b> | <b>Data</b> |
