# Access Compliance Report

## Public Rights-of-Way

### (Curb Ramps)

Intersection ID: 5052	Main Street: HEDGECREST_PL	Cross Street: LAZY_DAY_LN	Location: SW
ADA ID: 0D08C8B3BB36	Ramp Type: Perp	Initial Pass/Fail: Fail	Overall Compliance: No Severity Score: 13.75

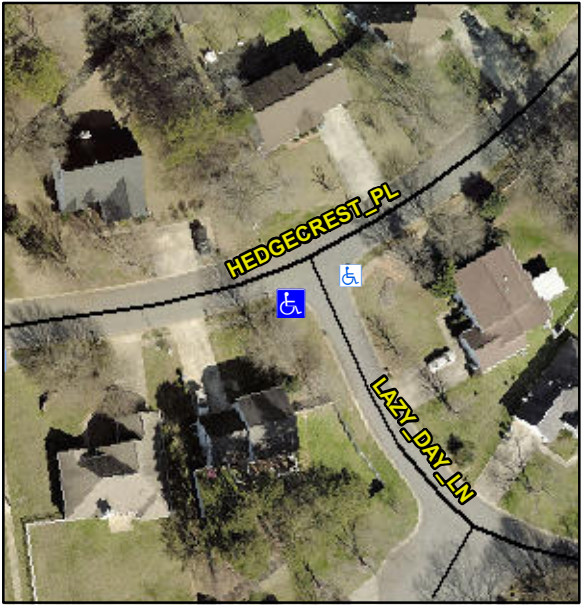
Possible Solutions:		<b>Compliance</b>	<b>Description</b>	<b>Data</b>
	<b>Remove &amp; Replace Entire Ramp.</b>		<b>No</b>	Ramp Length (in)	<b>87.0</b>
			<b>Yes</b>	Ramp Width (in)	<b>48.0</b>
			<b>N/A</b>	Flare Type LT	<b>N/A</b>
			<b>N/A</b>	Flare Slope LT (%)	<b>N/A</b>
			<b>N/A</b>	Flare Traversable LT?	<b>N/A</b>
			<b>N/A</b>	Landing Length (in)	<b>N/A</b>
			<b>N/A</b>	Landing Width (in)	<b>N/A</b>
			<b>N/A</b>	Landing Slope (%)	<b>N/A</b>
			<b>N/A</b>	Landing X Slope (%)	<b>N/A</b>
<p>Surveyor Notes:</p> <p><b>N/A</b></p> <p>PROW/ADA:</p> <p><b>Not Found, R304.2.2, R304.5.3</b></p>			<b>N/A</b>	Flare Type RT	<b>N/A</b>
			<b>N/A</b>	Flare Slope RT (%)	<b>N/A</b>
			<b>N/A</b>	Flare Traversable RT?	<b>N/A</b>
			<b>N/A</b>	DWS Provided?	<b>N/A</b>
			<b>N/A</b>	DWS Contrast?	<b>N/A</b>
			<b>N/A</b>	DWS Length (in)	<b>N/A</b>
