# Access Compliance Report

## Public Rights-of-Way

### (Curb Ramps)

Intersection ID: 30109	Main Street: HARLAND_ST	Cross Street: WANDERING_CREEK_DR	Location: N
ADA ID: 0D091313DC82	Ramp Type: PerpDiag	Initial Pass/Fail: Fail	Overall Compliance: No
Severity Score: 8.75			
Codes/Mitigation Info/Possible Solution		Field Measurements/Component Compliance

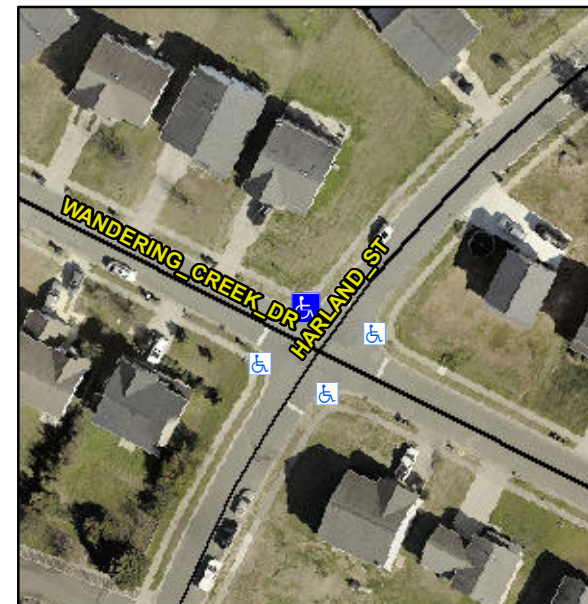
**Not Found, R304.5.1**

Compliance	Description	Data	Compliance	Description	Data
N/A	Ramp Length (in)	46.0	Yes	Ramp Slope (%)	5.1
No	Ramp Width (in)	39.0	Yes	Ramp XSlope (%)	0.3
N/A	Flare Type LT	N/A	N/A	Flare Type RT	N/A
N/A	Flare Slope LT (%)	N/A	N/A	Flare Slope RT (%)	N/A
N/A	Flare Traversable LT?	N/A	N/A	Flare Traversable RT?	N/A
N/A	Landing Length (in)	N/A	N/A	DWS Provided?	N/A
N/A	Landing Width (in)	N/A	N/A	DWS Contrast?	N/A
N/A	Landing Slope (%)	N/A	N/A	DWS Length (in)	N/A
N/A	Landing X Slope (%)	N/A	N/A	DWS Full Width?	N/A
N/A	Landing Curb? (Y/N)	N/A	N/A	DWS Offset (in)	N/A
N/A	Shared Landing?	N/A			
N/A	Gutter Ponding?	N/A	N/A	Gutter Slope (%)	N/A
N/A	Gutter Lip Ht (in)	N/A	N/A	Gutter X Slope (%)	N/A
N/A	Painted X Walk1?	No	N/A	Painted X Walk2?	No
	X Walk 1 Direction	To SW		X Walk 2 Direction	To SE
N/A	X Walk 1 Width (in)	N/A	N/A	X Walk 2 Width (in)	N/A
	X Walk 1 Slope (%)	4.3		X Walk 2 Slope (%)	1.4
	X Walk 1 X Slope (%)	3.4		X Walk 2 X Slope (%)	5.8

N/A	Ramp inside XWalk1?	N/A	N/A	Ramp inside XWalk2?	N/A
	Road Slope (%)	4.5	N/A	Clear Space?	N/A
	Road X Slope (%)	3.6	N/A	Clear Space to XWalk (in)	N/A
N/A	Any Obstructions?	N/A	N/A	Storm Grate/Utility Hazard?	N/A
	Obstruction Type			Storm Grate/Utility Type	
		N/A			N/A
		Yes		Surface Condition? (G/P)	Good

**Remove & Replace Curb Ramp With Two New Directional Ramps or Equivalent.**
