# Access Compliance Report

## Public Rights-of-Way

### (Curb Ramps)

Intersection ID: 27333	Main Street: BALLANTYNE_MEDICAL_PL	Cross Street: BRIXHAM_HILL_AV	Location: W
ADA ID: 0D0CAB74DCD0	Ramp Type: Perp	Initial Pass/Fail: Fail	Overall Compliance: No
Severity Score: 12.5			
Codes/Mitigation Info/Possible Solution		Field Measurements/Component Compliance

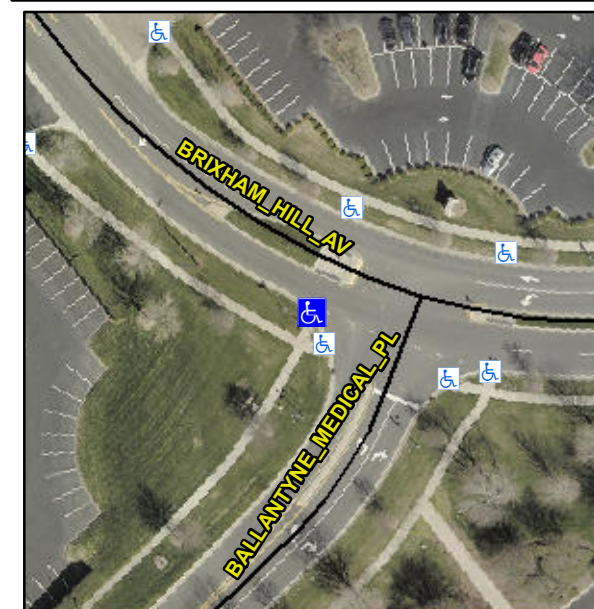
Compliance	Description	Data	Compliance	Description	Data
N/A	Ramp Length (in)	114.0	Yes	Ramp Slope (%)	6.6
Yes	Ramp Width (in)	55.0	No	Ramp XSlope (%)	5.3
N/A	Flare Type LT	N/A	N/A	Flare Type RT	N/A
N/A	Flare Slope LT (%)	N/A	N/A	Flare Slope RT (%)	N/A
N/A	Flare Traversable LT?	N/A	N/A	Flare Traversable RT?	N/A
N/A	Landing Length (in)	N/A	N/A	DWS Provided?	N/A
N/A	Landing Width (in)	N/A	N/A	DWS Contrast?	N/A
N/A	Landing Slope (%)	N/A	N/A	DWS Length (in)	N/A
N/A	Landing X Slope (%)	N/A	N/A	DWS Full Width?	N/A
N/A	Landing Curb? (Y/N)	N/A	N/A	DWS Offset (in)	N/A
N/A	Shared Landing?	N/A			
N/A	Gutter Ponding?	N/A	N/A	Gutter Slope (%)	N/A
N/A	Gutter Lip Ht (in)	N/A	N/A	Gutter X Slope (%)	N/A
N/A	Painted X Walk1?	No	N/A	Painted X Walk2?	N/A
	X Walk 1 Direction	To NE		X Walk 2 Direction	N/A
N/A	X Walk 1 Width (in)	N/A	N/A	X Walk 2 Width (in)	N/A
	X Walk 1 Slope (%)	4.5		X Walk 2 Slope (%)	N/A
	X Walk 1 X Slope (%)	0.3		X Walk 2 X Slope (%)	N/A

Possible Solutions:

**Remove & Replace Entire Ramp.**
