# Access Compliance Report

## Public Rights-of-Way

### (Curb Ramps)

Intersection ID: N/A	Main Street: LANGWELL_LN	Cross Street: HAMILTON_BRIDGE_RD	Location: SE
ADA ID: 0D0E3C20A197	Ramp Type: Perp	Initial Pass/Fail: Fail	Overall Compliance: No
Codes/Mitigation Info/Possible Solution		Field Measurements/Component Compliance	
Severity Score: 10

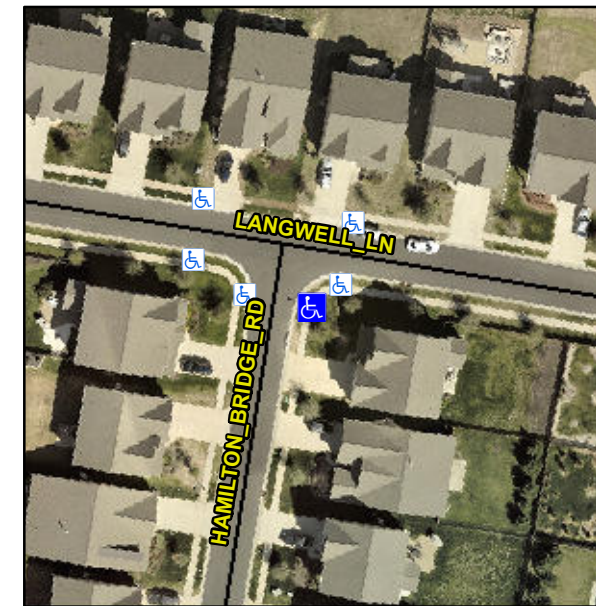
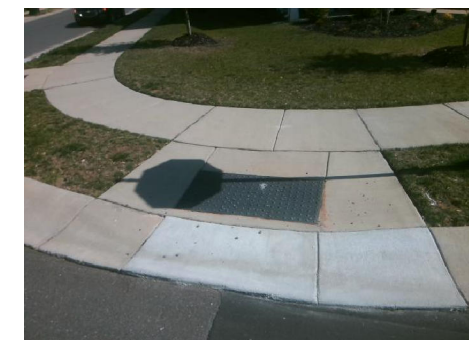
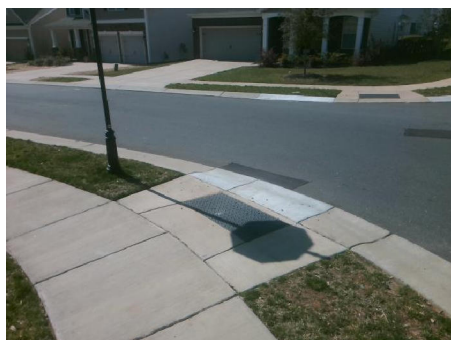
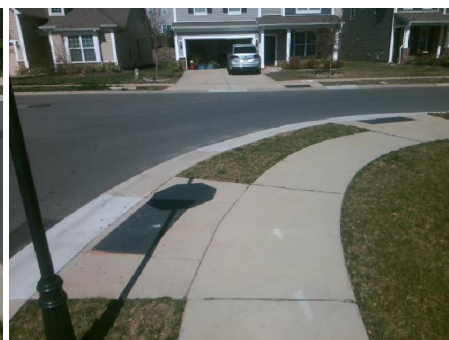
**R304.5.1, R304.5.3**

Compliance	Description	Data	Compliance	Description	Data
N/A	Ramp Length (in)	47.5	Yes	Ramp Slope (%)	5.6
No	Ramp Width (in)	47.5	No	Ramp XSlope (%)	2.6
N/A	Flare Type LT	N/A	N/A	Flare Type RT	N/A
N/A	Flare Slope LT (%)	N/A	N/A	Flare Slope RT (%)	N/A
N/A	Flare Traversable LT?	N/A	N/A	Flare Traversable RT?	N/A
N/A	Landing Length (in)	N/A	N/A	DWS Provided?	N/A
N/A	Landing Width (in)	N/A	N/A	DWS Contrast?	N/A
N/A	Landing Slope (%)	N/A	N/A	DWS Length (in)	N/A
N/A	Landing X Slope (%)	N/A	N/A	DWS Full Width?	N/A
N/A	Landing Curb? (Y/N)	N/A	N/A	DWS Offset (in)	N/A
N/A	Shared Landing?	N/A			
N/A	Gutter Ponding?	N/A	N/A	Gutter Slope (%)	N/A
N/A	Gutter Lip Ht (in)	N/A	N/A	Gutter X Slope (%)	N/A
N/A	Painted X Walk1?	No	N/A	Painted X Walk2?	N/A
	X Walk 1 Direction	To W		X Walk 2 Direction	N/A
N/A	X Walk 1 Width (in)	N/A	N/A	X Walk 2 Width (in)	N/A
	X Walk 1 Slope (%)	0.6		X Walk 2 Slope (%)	N/A
	X Walk 1 X Slope (%)	5.0		X Walk 2 X Slope (%)	N/A

N/A	Ramp inside XWalk1?	N/A	N/A	Ramp inside XWalk2?	N/A
	Road Slope (%)	N/A	N/A	Clear Space?	N/A
	Road X Slope (%)	N/A	N/A	Clear Space to XWalk (in)	N/A
N/A	Any Obstructions?	N/A	N/A	Storm Grate/Utility Hazard?	N/A
	Obstruction Type			Storm Grate/Utility Type	
		N/A			N/A
			Yes	Surface Condition? (G/P)	Good

**Remove & Replace Entire Ramp.**

Total Cost: \$ 1850.00
