# Access Compliance Report

## Public Rights-of-Way

### (Curb Ramps)

| Intersection ID: 10027081 | Main Street: GALLERIA_BV | Cross Street: N/A | Location: W |

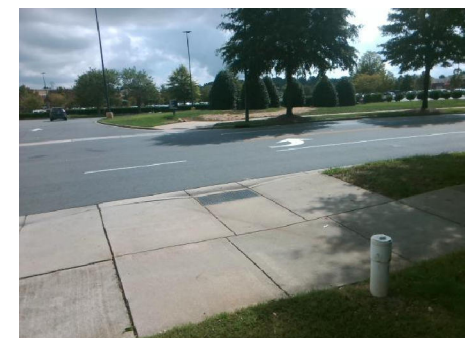
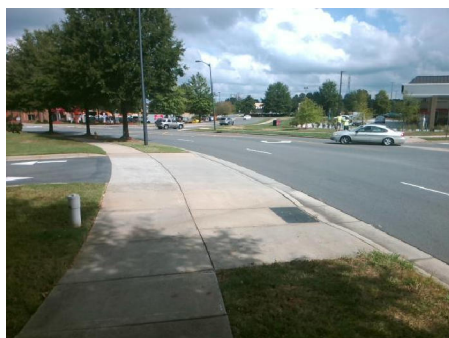
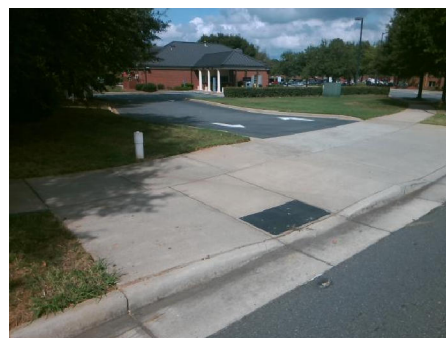
| ADA ID: 0D10374EE619 | Ramp Type: BlendTrans1 | Initial Pass/Fail: Fail | Overall Compliance: No |

**Not Found, R304.5.1**

| Compliance | Description | Data | Compliance | Description | Data |
|---|---|---|---|---|---|
| No | Ramp Width (in) | 47.0 | Yes | BlendTrans XSlope (%) | 2.3 |
| | | | No | Curb Slope (%) | 5.8 |

**Remove & Replace Curb Ramp With Two New Directional Ramps or Equivalent.**
