# Access Compliance Report

## Public Rights-of-Way

### (Curb Ramps)

Intersection ID: 12257	Main Street: W_3RD_ST	Cross Street: S_POPLAR_ST	Location: S
ADA ID: 0D19595A1F97	Ramp Type: Perp	Initial Pass/Fail: Fail	Overall Compliance: No
		Severity Score: 12.5

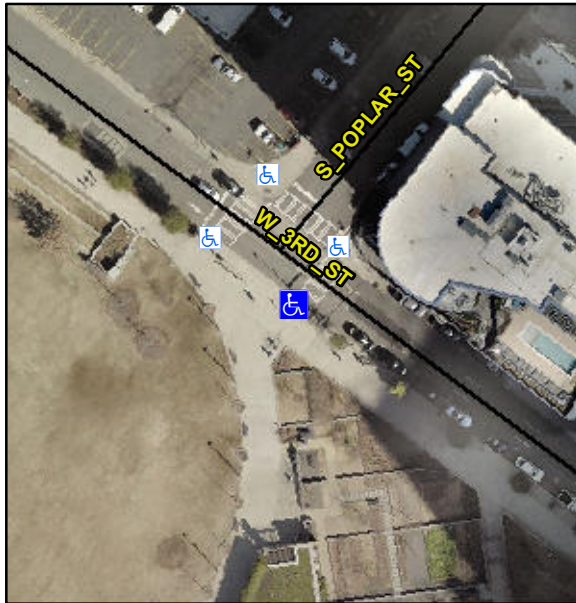
Compliance	Description	Data	Compliance	Description	Data
N/A	Ramp Length (in)	94.0	No	Ramp Slope (%)	9.7
Yes	Ramp Width (in)	53.0	Yes	Ramp XSlope (%)	0.2
N/A	Flare Type LT	N/A	N/A	Flare Type RT	N/A
N/A	Flare Slope LT (%)	N/A	N/A	Flare Slope RT (%)	N/A
N/A	Flare Traversable LT?	N/A	N/A	Flare Traversable RT?	N/A
N/A	Landing Length (in)	N/A	N/A	DWS Provided?	N/A
N/A	Landing Width (in)	N/A	N/A	DWS Contrast?	N/A
N/A	Landing Slope (%)	N/A	N/A	DWS Length (in)	N/A
N/A	Landing X Slope (%)	N/A	N/A	DWS Full Width?	N/A
N/A	Landing Curb? (Y/N)	N/A	N/A	DWS Offset (in)	N/A
N/A	Shared Landing?	N/A			
N/A	Gutter Ponding?	N/A	N/A	Gutter Slope (%)	N/A
N/A	Gutter Lip Ht (in)	N/A	N/A	Gutter X Slope (%)	N/A
N/A	Painted X Walk1?	Yes	N/A	Painted X Walk2?	N/A
	X Walk 1 Direction	To NE		X Walk 2 Direction	N/A
N/A	X Walk 1 Width (in)	123.0	N/A	X Walk 2 Width (in)	N/A
	X Walk 1 Slope (%)	1.4		X Walk 2 Slope (%)	N/A
	X Walk 1 X Slope (%)	3.5		X Walk 2 X Slope (%)	N/A

N/A	Ramp inside XWalk1?	Yes	N/A	Ramp inside XWalk2?	N/A
	Road Slope (%)	N/A	N/A	Clear Space?	N/A
	Road X Slope (%)	N/A	N/A	Clear Space to XWalk (in)	N/A
N/A	Any Obstructions?	N/A	N/A	Storm Grate/Utility Hazard?	N/A
	Obstruction Type			Storm Grate/Utility Type	
		N/A			N/A
			Yes	Surface Condition? (G/P)	Good

Possible Solutions:

**Remove & Replace Entire Ramp.**

**Not Found, R304.2.2**
