| Intersection ID: 44064 | Main Street: SEDGEMOOR_LN | Cross Street: LONGSTONE_LN | Location: | W |
| ADA ID: 0D1DC4FD4831 | Ramp Type: BlendTrans1 | Initial Pass/Fail: Fail | Overall Compliance: No | Severity Score: 36.25 |

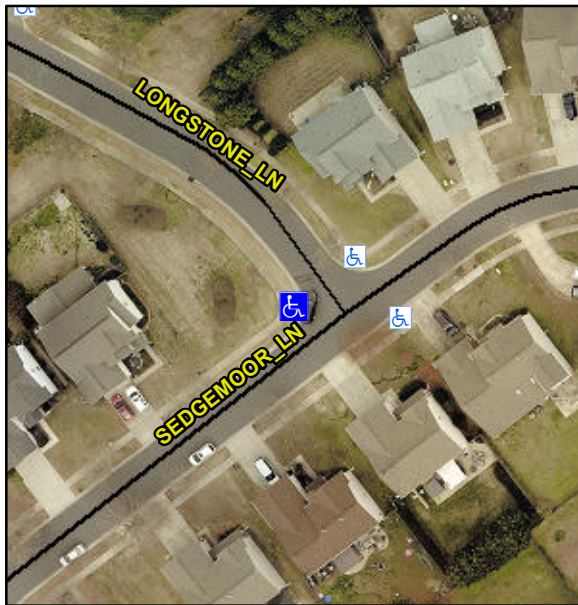
### R304.5.1, R304.5.3

| Compliance | Description | Data | Compliance | Description | Data |
|---|---|---|---|---|---|
| No | Ramp Width (in) | 25.0 | No | BlendTrans XSlope (%) | 2.9 |

**Remove & Replace Curb Ramp With Two New Directional Ramps or Equivalent.**
