Access Compliance Report

Public Rights-of-Way

(Curb Ramps)

Intersection ID: 26425	Main Street: BEVINGTON_PL	Cross Street: BIRKDALE VALLEY DR	Location: NW
ADA ID: 0D2A2A5B37E9	Ramp Type: PerpDiag	Initial Pass/Fail: Fail	Overall Compliance: No
		Severity Score: 25

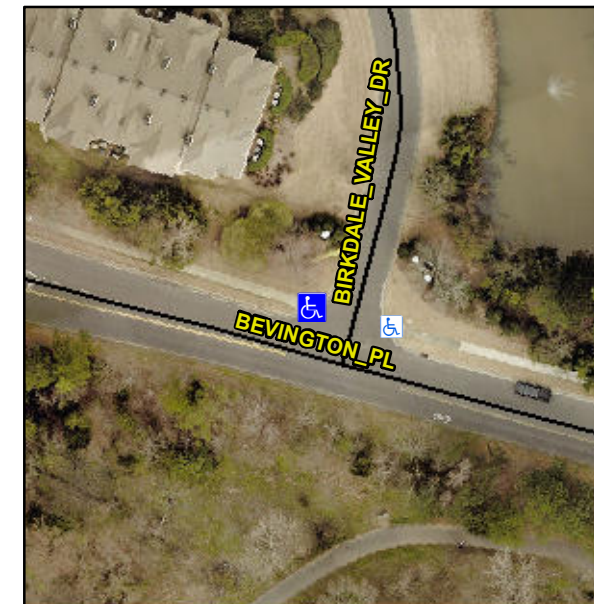
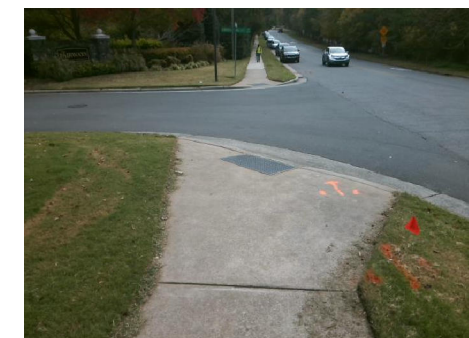
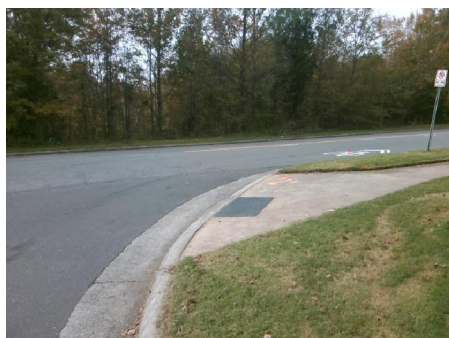
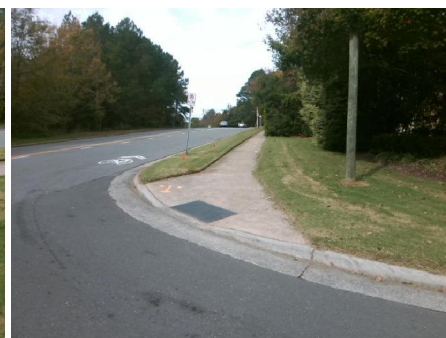
Not Found, R304.2.2, R304.5.3

Compliance	Description	Data	Compliance	Description	Data
N/A	Ramp Length (in)	71.0	No	Ramp Slope (%)	11.3
Yes	Ramp Width (in)	48.0	No	Ramp XSlope (%)	5.6
N/A	Flare Type LT	N/A	N/A	Flare Type RT	N/A
N/A	Flare Slope LT (%)	N/A	N/A	Flare Slope RT (%)	N/A
N/A	Flare Traversable LT?	N/A	N/A	Flare Traversable RT?	N/A
N/A	Landing Length (in)	N/A	N/A	DWS Provided?	N/A
N/A	Landing Width (in)	N/A	N/A	DWS Contrast?	N/A
N/A	Landing Slope (%)	N/A	N/A	DWS Length (in)	N/A
N/A	Landing X Slope (%)	N/A	N/A	DWS Full Width?	N/A
N/A	Landing Curb? (Y/N)	N/A	N/A	DWS Offset (in)	N/A
N/A	Shared Landing?	N/A			
N/A	Gutter Ponding?	N/A	N/A	Gutter Slope (%)	N/A
N/A	Gutter Lip Ht (in)	N/A	N/A	Gutter X Slope (%)	N/A
N/A	Painted X Walk1?	No	N/A	Painted X Walk2?	No
	X Walk 1 Direction	To SW		X Walk 2 Direction	To E
N/A	X Walk 1 Width (in)	N/A	N/A	X Walk 2 Width (in)	N/A
	X Walk 1 Slope (%)	5.7		X Walk 2 Slope (%)	7.5
	X Walk 1 X Slope (%)	4.2		X Walk 2 X Slope (%)	1.9

N/A	Ramp inside XWalk1?	N/A	N/A	Ramp inside XWalk2?	N/A
	Road Slope (%)	5.4	N/A	Clear Space?	N/A
	Road X Slope (%)	0.8	N/A	Clear Space to XWalk (in)	N/A
N/A	Any Obstructions?	N/A	N/A	Storm Grate/Utility Hazard?	N/A
	Obstruction Type			Storm Grate/Utility Type	
		N/A			N/A
			Yes	Surface Condition? (G/P)	Good

Remove & Replace Curb Ramp With Two New Directional Ramps or Equivalent.
