Access Compliance Report

Public Rights-of-Way

(Curb Ramps)

Intersection ID: 27397	Main Street: ELM_LN	Cross Street: BALLANTYNE_COMMONS_PY	Location: SW
ADA ID: 0D37EA318C9E	Ramp Type: Perp	Initial Pass/Fail: Fail	Overall Compliance: No
Severity Score: 21.25			
Codes/Mitigation Info/Possible Solution		Field Measurements/Component Compliance

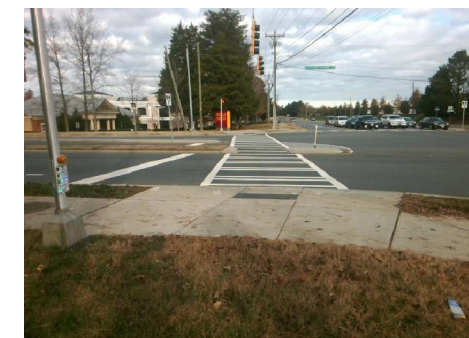
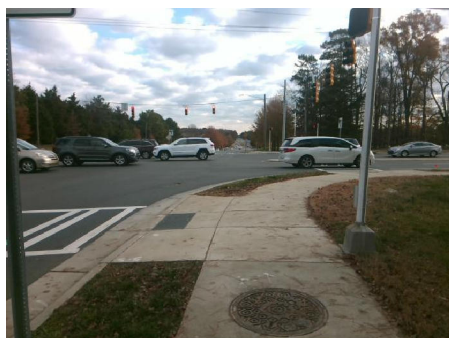
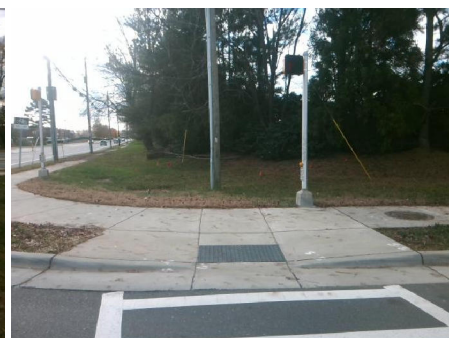
Not Found, R304.5.1, R304.2.2

Compliance	Description	Data	Compliance	Description	Data
N/A	Ramp Length (in)	47.0	No	Ramp Slope (%)	8.8
No	Ramp Width (in)	47.5	Yes	Ramp XSlope (%)	1.9
N/A	Flare Type LT	N/A	N/A	Flare Type RT	N/A
N/A	Flare Slope LT (%)	N/A	N/A	Flare Slope RT (%)	N/A
N/A	Flare Traversable LT?	N/A	N/A	Flare Traversable RT?	N/A
N/A	Landing Length (in)	N/A	N/A	DWS Provided?	N/A
N/A	Landing Width (in)	N/A	N/A	DWS Contrast?	N/A
N/A	Landing Slope (%)	N/A	N/A	DWS Length (in)	N/A
N/A	Landing X Slope (%)	N/A	N/A	DWS Full Width?	N/A
N/A	Landing Curb? (Y/N)	N/A	N/A	DWS Offset (in)	N/A
N/A	Shared Landing?	N/A			
N/A	Gutter Ponding?	N/A	N/A	Gutter Slope (%)	N/A
N/A	Gutter Lip Ht (in)	N/A	N/A	Gutter X Slope (%)	N/A
N/A	Painted X Walk1?	Yes	N/A	Painted X Walk2?	N/A
	X Walk 1 Direction	To NW		X Walk 2 Direction	N/A
N/A	X Walk 1 Width (in)	116.0	N/A	X Walk 2 Width (in)	N/A
	X Walk 1 Slope (%)	2.7		X Walk 2 Slope (%)	N/A
	X Walk 1 X Slope (%)	0.8		X Walk 2 X Slope (%)	N/A

N/A	Ramp inside XWalk1?	Yes	N/A	Ramp inside XWalk2?	N/A
	Road Slope (%)	N/A	N/A	Clear Space?	N/A
	Road X Slope (%)	N/A	N/A	Clear Space to XWalk (in)	N/A
N/A	Any Obstructions?	N/A	N/A	Storm Grate/Utility Hazard?	N/A
	Obstruction Type			Storm Grate/Utility Type	
		N/A			N/A
		Yes		Surface Condition? (G/P)	Good

Remove & Replace Entire Ramp.
