Access Compliance Report Public Rights-of-Way (Curb Ramps)

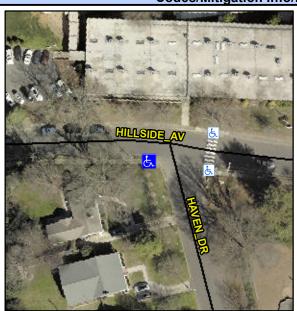
Intersection ID: 17425 Main Street: HAVEN_DR Cross Street: HILLSIDE_AV Location: SW

Total Cost: \$ 3200.00

Fleid Measurements/Component Compnance								
	Compliance Description		Data	Compliance Description		Data		
	N/A	Ramp Length (in)	43.0	No	Ramp Slope (%)	8.5		
	No	Ramp Width (in)	43.0	Yes	Ramp XSlope (%)	0.2		
	N/A	Flare Type LT	N/A	N/A	Flare Type RT	N/A		
	N/A	Flare Slope LT (%)	N/A	N/A	Flare Slope RT (%)	N/A		
	N/A	Flare Traversable LT?	N/A	N/A	Flare Traversable RT?	N/A		
	N/A	Landing Length (in)	N/A	N/A	DWS Provided?	N/A		
	N/A	Landing Width (in)	N/A	N/A	DWS Contrast?	N/A		
	N/A	Landing Slope (%)	N/A	N/A	DWS Length (in)	N/A		
	N/A	Landing X Slope (%)	N/A	N/A	DWS Full Width?	N/A		
	N/A	Landing Curb? (Y/N)	N/A	N/A	DWS Offset (in)	N/A		
	N/A	Shared Landing?	N/A					
	N/A	Gutter Ponding?	N/A	N/A	Gutter Slope (%)	N/A		
	N/A	Gutter Lip Ht (in)	N/A	N/A	Gutter X Slope (%)	N/A		
	N/A	Painted X Walk1?	No	N/A	Painted X Walk2?	No		
		X Walk 1 Direction	To SE		X Walk 2 Direction	To N		
	N/A	X Walk 1 Width (in)	N/A	N/A	X Walk 2 Width (in)	N/A

HAVEN DR StopSign HILLSIDE AV Signal
