# Access Compliance Report

## Public Rights-of-Way (Curb Ramps)

Intersection ID: 3079	Main Street: BLACK_MAPLE_AV	Cross Street: PLACER_MAPLE_LN	Location: NW
ADA ID: 0D5C63AD001E	Ramp Type: Perp	Initial Pass/Fail: Fail	Overall Compliance: No
Severity Score: 22.5			
Codes/Mitigation Info/Possible Solution		Field Measurements/Component Compliance

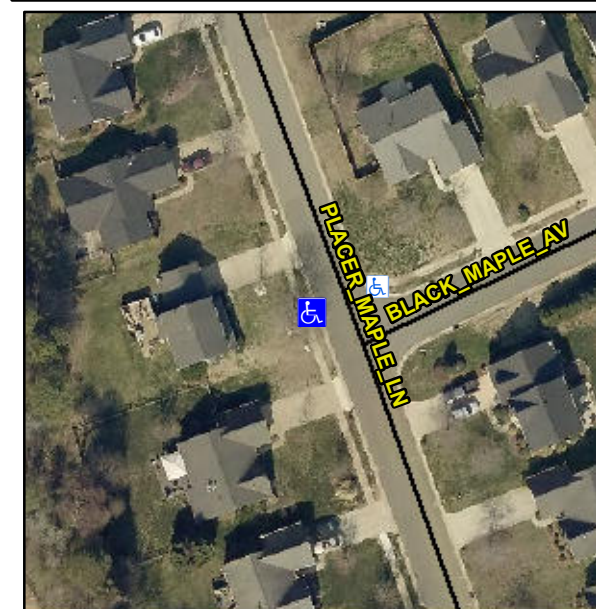
**Not Found, R304.5.1, R304.2.2, R304.5.3**

Compliance	Description	Data	Compliance	Description	Data
N/A	Ramp Length (in)	48.5	No	Ramp Slope (%)	8.8
No	Ramp Width (in)	45.0	No	Ramp XSlope (%)	3.7
N/A	Flare Type LT	N/A	N/A	Flare Type RT	N/A
N/A	Flare Slope LT (%)	N/A	N/A	Flare Slope RT (%)	N/A
N/A	Flare Traversable LT?	N/A	N/A	Flare Traversable RT?	N/A
N/A	Landing Length (in)	N/A	N/A	DWS Provided?	N/A
N/A	Landing Width (in)	N/A	N/A	DWS Contrast?	N/A
N/A	Landing Slope (%)	N/A	N/A	DWS Length (in)	N/A
N/A	Landing X Slope (%)	N/A	N/A	DWS Full Width?	N/A
N/A	Landing Curb? (Y/N)	N/A	N/A	DWS Offset (in)	N/A
N/A	Shared Landing?	N/A			
N/A	Gutter Ponding?	N/A	N/A	Gutter Slope (%)	N/A
N/A	Gutter Lip Ht (in)	N/A	N/A	Gutter X Slope (%)	N/A
N/A	Painted X Walk1?	No	N/A	Painted X Walk2?	N/A
	X Walk 1 Direction	To E		X Walk 2 Direction	N/A
N/A	X Walk 1 Width (in)	N/A	N/A	X Walk 2 Width (in)	N/A
	X Walk 1 Slope (%)	2.0		X Walk 2 Slope (%)	N/A
	X Walk 1 X Slope (%)	2.9		X Walk 2 X Slope (%)	N/A

N/A	Ramp inside XWalk1?	N/A	N/A	Ramp inside XWalk2?	N/A
	Road Slope (%)	N/A	N/A	Clear Space?	N/A
	Road X Slope (%)	N/A	N/A	Clear Space to XWalk (in)	N/A
N/A	Any Obstructions?	N/A	N/A	Storm Grate/Utility Hazard?	N/A
	Obstruction Type			Storm Grate/Utility Type	
		N/A			N/A
			Yes	Surface Condition? (G/P)	Good

Possible Solutions:

**Remove & Replace Entire Ramp.**
