Access Compliance Report

Public Rights-of-Way

(Curb Ramps)

Intersection ID: 10306	Main Street: W_24TH_ST	Cross Street: BANCROFT_ST	Location: W
ADA ID: 0D61D9A936B4	Ramp Type: PerpDiag	Initial Pass/Fail: Fail	Overall Compliance: No
Severity Score: 21.25			
Codes/Mitigation Info/Possible Solution		Field Measurements/Component Compliance

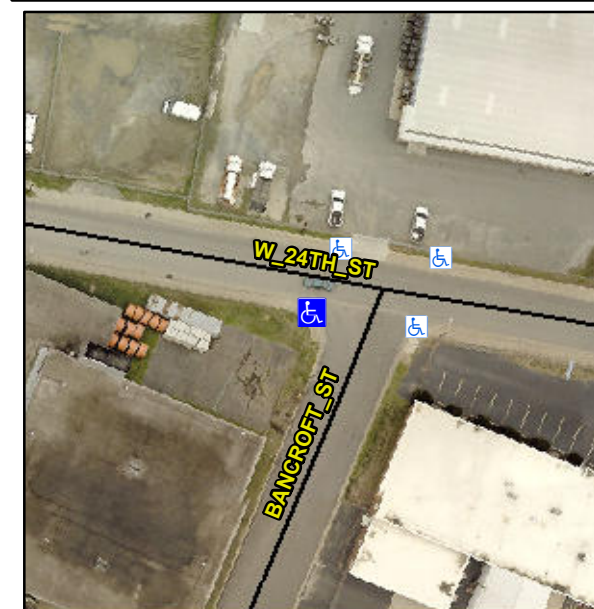
Not Found, R304.5.1, R304.2.2

Compliance	Description	Data	Compliance	Description	Data
N/A	Ramp Length (in)	59.0	No	Ramp Slope (%)	10.3
No	Ramp Width (in)	40.0	Yes	Ramp XSlope (%)	0.1
N/A	Flare Type LT	N/A	N/A	Flare Type RT	N/A
N/A	Flare Slope LT (%)	N/A	N/A	Flare Slope RT (%)	N/A
N/A	Flare Traversable LT?	N/A	N/A	Flare Traversable RT?	N/A
N/A	Landing Length (in)	N/A	N/A	DWS Provided?	N/A
N/A	Landing Width (in)	N/A	N/A	DWS Contrast?	N/A
N/A	Landing Slope (%)	N/A	N/A	DWS Length (in)	N/A
N/A	Landing X Slope (%)	N/A	N/A	DWS Full Width?	N/A
N/A	Landing Curb? (Y/N)	N/A	N/A	DWS Offset (in)	N/A
N/A	Shared Landing?	N/A			
N/A	Gutter Ponding?	N/A	N/A	Gutter Slope (%)	N/A
N/A	Gutter Lip Ht (in)	0.75	N/A	Gutter X Slope (%)	N/A
N/A	Painted X Walk1?	No	N/A	Painted X Walk2?	No
	X Walk 1 Direction	To SE		X Walk 2 Direction	To NE
N/A	X Walk 1 Width (in)	N/A	N/A	X Walk 2 Width (in)	N/A
	X Walk 1 Slope (%)	0.3		X Walk 2 Slope (%)	2.7
	X Walk 1 X Slope (%)	1.7		X Walk 2 X Slope (%)	1.0

N/A	Ramp inside XWalk1?	N/A	N/A	Ramp inside XWalk2?	N/A
	Road Slope (%)	0.1	N/A	Clear Space?	N/A
	Road X Slope (%)	1.4	N/A	Clear Space to XWalk (in)	N/A
N/A	Any Obstructions?	N/A	N/A	Storm Grate/Utility Hazard?	N/A
	Obstruction Type			Storm Grate/Utility Type	
		N/A			N/A
			Yes	Surface Condition? (G/P)	Good

Remove & Replace Curb Ramp With Two New Directional Ramps or Equivalent.
