Access Compliance Report

Public Rights-of-Way

(Curb Ramps)

Intersection ID: 31415	Main Street: PENDRAGON_DR	Cross Street: ROCKWELL_CHURCH_RD	Location: W
ADA ID: 0D6E12D38D92	Ramp Type: Perp	Initial Pass/Fail: Fail	Overall Compliance: No
Severity Score: 8.75			
Codes/Mitigation Info/Possible Solution		Field Measurements/Component Compliance

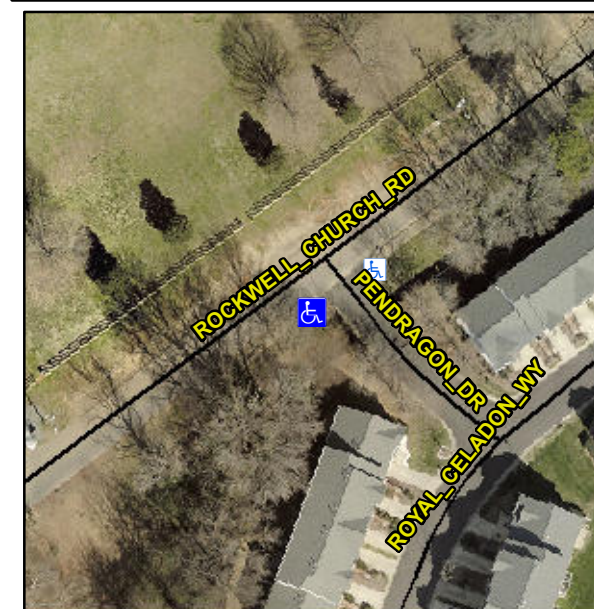
Not Found, R304.5.1

Compliance	Description	Data	Compliance	Description	Data
N/A	Ramp Length (in)	61.0	Yes	Ramp Slope (%)	5.9
No	Ramp Width (in)	42.0	Yes	Ramp XSlope (%)	0.9
N/A	Flare Type LT	N/A	N/A	Flare Type RT	N/A
N/A	Flare Slope LT (%)	N/A	N/A	Flare Slope RT (%)	N/A
N/A	Flare Traversable LT?	N/A	N/A	Flare Traversable RT?	N/A
N/A	Landing Length (in)	N/A	N/A	DWS Provided?	N/A
N/A	Landing Width (in)	N/A	N/A	DWS Contrast?	N/A
N/A	Landing Slope (%)	N/A	N/A	DWS Length (in)	N/A
N/A	Landing X Slope (%)	N/A	N/A	DWS Full Width?	N/A
N/A	Landing Curb? (Y/N)	N/A	N/A	DWS Offset (in)	N/A
N/A	Shared Landing?	N/A			
N/A	Gutter Ponding?	Yes	N/A	Gutter Slope (%)	N/A
N/A	Gutter Lip Ht (in)	N/A	N/A	Gutter X Slope (%)	N/A
N/A	Painted X Walk1?	No	N/A	Painted X Walk2?	N/A
	X Walk 1 Direction	To NE		X Walk 2 Direction	N/A
N/A	X Walk 1 Width (in)	N/A	N/A	X Walk 2 Width (in)	N/A
	X Walk 1 Slope (%)	0.9		X Walk 2 Slope (%)	N/A
	X Walk 1 X Slope (%)	2.6		X Walk 2 X Slope (%)	N/A

N/A	Ramp inside XWalk1?	N/A	N/A	Ramp inside XWalk2?	N/A
	Road Slope (%)	N/A	N/A	Clear Space?	N/A
	Road X Slope (%)	N/A	N/A	Clear Space to XWalk (in)	N/A
N/A	Any Obstructions?	N/A	N/A	Storm Grate/Utility Hazard?	N/A
	Obstruction Type			Storm Grate/Utility Type	
		N/A			N/A
		Yes		Surface Condition? (G/P)	Good

Possible Solutions:

Remove & Replace Entire Ramp.
