Access Compliance Report

Public Rights-of-Way

(Curb Ramps)

Intersection ID: 7010	Main Street: BLUE_HAMPTON_LN	Cross Street: KINGVILLE_DR	Location: E
ADA ID: 0D751AE6E0F4	Ramp Type: Combination2	Initial Pass/Fail: Fail	Overall Compliance: No
Codes/Mitigation Info/Possible Solution		Field Measurements/Component Compliance

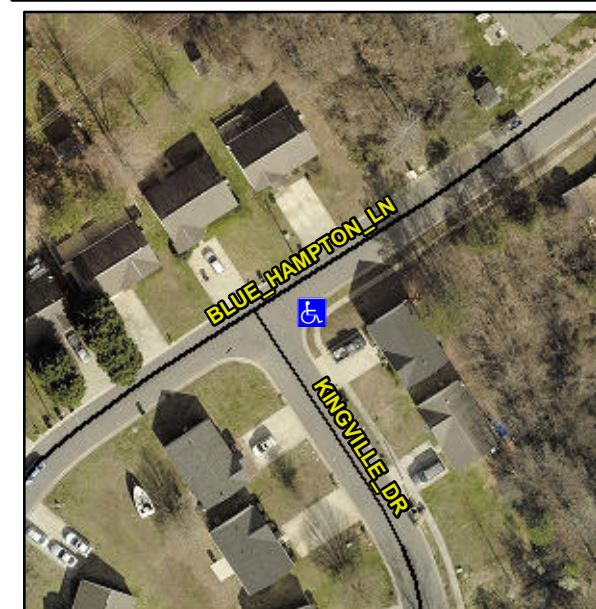
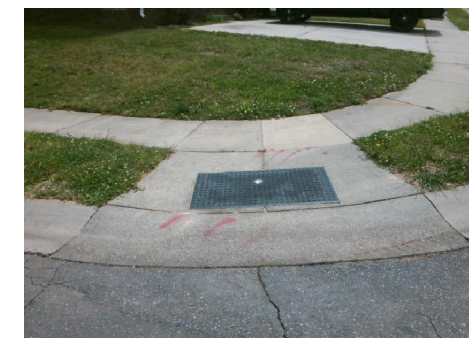
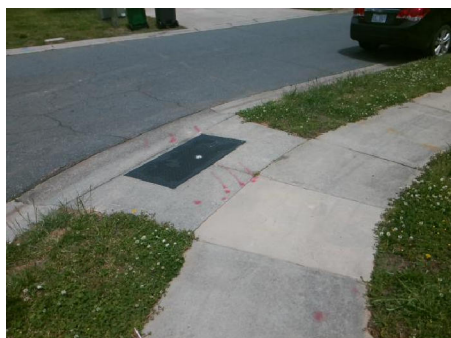
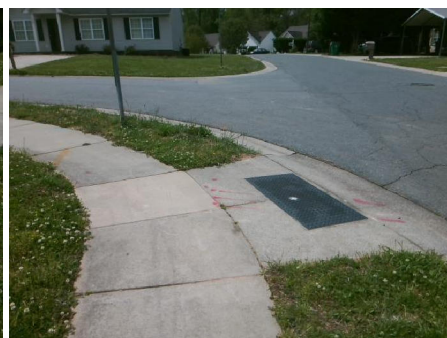
LT RP < 5%

Not Found, R304.5.1, R304.5.3, R304.3.2

Compliance	Description	Data	Compliance	Description	Data
N/A	Ramp Length LT (in)	7.5	N/A	Ramp Length RT (in)	13.0
N/A	Ramp Width LT (in)	46.0	No	Ramp Width RT (in)	46.0
N/A	Ramp Slope LT (%)	4.2	No	Ramp Slope RT (%)	9.1
N/A	Ramp XSlope LT (%)	2.5	No	Ramp XSlope RT (%)	2.4
N/A	Ramp Length (in)	47.0	Yes	Ramp Slope (%)	5.1
Yes	Ramp Width (in)	48.0	No	Ramp XSlope (%)	7.2
N/A	Flare Type LT	N/A	N/A	Flare Type RT	N/A
N/A	Flare Slope LT (%)	N/A	N/A	Flare Slope RT (%)	N/A
N/A	Flare Traversable LT?	N/A	N/A	Flare Traversable RT?	N/A
N/A	Landing Length (in)	N/A	N/A	DWS Provided?	N/A
N/A	Landing Width (in)	N/A	N/A	DWS Contrast?	N/A
N/A	Landing Slope (%)	N/A	N/A	DWS Length (in)	N/A
N/A	Landing X Slope (%)	N/A	N/A	DWS Full Width?	N/A
N/A	Landing Curb? (Y/N)	N/A	N/A	DWS Offset (in)	N/A
N/A	Shared Landing?	N/A			
N/A	Gutter Ponding?	N/A	N/A	Gutter Slope (%)	N/A
N/A	Gutter Lip Ht (in)	N/A	N/A	Gutter X Slope (%)	N/A
N/A	Painted X Walk1?	No	N/A	Painted X Walk2?	N/A

X Walk 1 Direction	To SW		X Walk 2 Direction	N/A
	X Walk 1 Width (in)	N/A		X Walk 2 Width (in)	N/A
	X Walk 1 Slope (%)	4.1		X Walk 2 Slope (%)	N/A
	X Walk 1 X Slope (%)	5.4		X Walk 2 X Slope (%)	N/A
N/A	Ramp inside XWalk1?	N/A	N/A	Ramp inside XWalk2?	N/A
	Road Slope (%)	N/A		Clear Space?	N/A
	Road X Slope (%)	N/A	N/A	Clear Space to XWalk (in)	N/A
			N/A	Any Obstruction?	N/A
				Obstruction Type	N/A
			N/A	Storm Grate/Utility Hazard?	N/A
				Storm Grate/Utility Type	N/A
Yes	Surface Condition? (G/P)	Good			
	Curb Slope (%)	16.4

Remove & Replace Entire Ramp.
