Access Compliance Report

Public Rights-of-Way (Curb Ramps)

Intersection ID: 28975	Main Street: BANNINGTON_RD	Cross Street: NORTHBURY_LN	Location: SW
ADA ID: 0D9047E1960C	Ramp Type: PerpDiag	Initial Pass/Fail: Fail	Overall Compliance: No Severity Score: 33.75

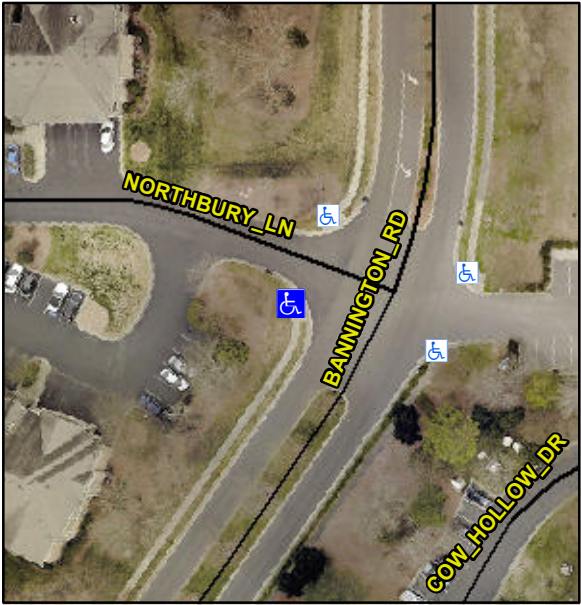
X Walk 1 Slope (%)	2.6
				X Walk 1 X Slope (%)	5.1
			N/A	Ramp inside XWalk1?	N/A
				Road Slope (%)	6.2
				Road X Slope (%)	2.2
			N/A	Any Obstructions?	N/A
				Obstruction Type	
Total Cost:			\$	3200.00

Possible Solutions:		Compliance	Description	Data
	Remove & Replace Curb Ramp With Two New Directional Ramps or Equivalent.		N/A	Ramp Length (in)	95.0
			No	Ramp Width (in)	38.0
			N/A	Flare Type LT	N/A
			N/A	Flare Slope LT (%)	N/A
			N/A	Flare Traversable LT?	N/A
			N/A	Landing Length (in)	N/A
			N/A	Landing Width (in)	N/A
			N/A	Landing Slope (%)	N/A
			N/A	Landing X Slope (%)	N/A
<p>Surveyor Notes:</p> <p>N/A</p> <p>PROW/ADA:</p> <p>Not Found, R304.5.1, R304.5.3</p>			N/A	Flare Type RT	N/A
			N/A	Flare Slope RT (%)	N/A
			N/A	Flare Traversable RT?	N/A
			N/A	DWS Provided?	N/A
			N/A	DWS Contrast?	N/A
			N/A	DWS Length (in)	N/A
			N/A	DWS Full Width?	N/A
			N/A	DWS Offset (in)	N/A
			N/A	Shared Landing?	N/A
			N/A	Gutter Ponding?	N/A
			N/A	Gutter Lip Ht (in)	N/A
			N/A	Painted X Walk1?	No
				X Walk 1 Direction	To E
			N/A	X Walk 1 Width (in)	N/A
