Access Compliance Report

Public Rights-of-Way

(Curb Ramps)

Intersection ID: 44780	Main Street: SESSIONS_ST	Cross Street: SILVER_CRESCENT_DR	Location: NE
ADA ID: 0D987524267B	Ramp Type: PerpDiag	Initial Pass/Fail: Fail	Overall Compliance: No
Severity Score: 12.5			
Codes/Mitigation Info/Possible Solution		Field Measurements/Component Compliance

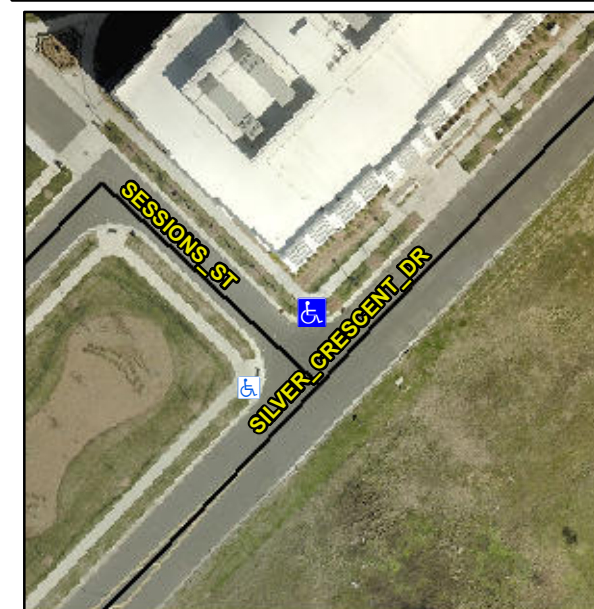
Not Found, R304.2.2

Compliance	Description	Data	Compliance	Description	Data
N/A	Ramp Length (in)	93.0	No	Ramp Slope (%)	9.2
Yes	Ramp Width (in)	60.0	Yes	Ramp XSlope (%)	1.3
N/A	Flare Type LT	N/A	N/A	Flare Type RT	N/A
N/A	Flare Slope LT (%)	N/A	N/A	Flare Slope RT (%)	N/A
N/A	Flare Traversable LT?	N/A	N/A	Flare Traversable RT?	N/A
N/A	Landing Length (in)	N/A	N/A	DWS Provided?	N/A
N/A	Landing Width (in)	N/A	N/A	DWS Contrast?	N/A
N/A	Landing Slope (%)	N/A	N/A	DWS Length (in)	N/A
N/A	Landing X Slope (%)	N/A	N/A	DWS Full Width?	N/A
N/A	Landing Curb? (Y/N)	N/A	N/A	DWS Offset (in)	N/A
N/A	Shared Landing?	N/A			
N/A	Gutter Ponding?	N/A	N/A	Gutter Slope (%)	N/A
N/A	Gutter Lip Ht (in)	N/A	N/A	Gutter X Slope (%)	N/A
N/A	Painted X Walk1?	No	N/A	Painted X Walk2?	No
	X Walk 1 Direction	To SW		X Walk 2 Direction	To SE
N/A	X Walk 1 Width (in)	N/A	N/A	X Walk 2 Width (in)	N/A
	X Walk 1 Slope (%)	1.1		X Walk 2 Slope (%)	4.2
	X Walk 1 X Slope (%)	1.9		X Walk 2 X Slope (%)	0.3

N/A	Ramp inside XWalk1?	N/A	N/A	Ramp inside XWalk2?	N/A
	Road Slope (%)	2.4	N/A	Clear Space?	N/A
	Road X Slope (%)	4.5	N/A	Clear Space to XWalk (in)	N/A
N/A	Any Obstructions?	N/A	N/A	Storm Grate/Utility Hazard?	N/A
	Obstruction Type			Storm Grate/Utility Type	
		N/A			N/A
		Yes		Surface Condition? (G/P)	Good

Remove & Replace Curb Ramp With Two New Directional Ramps or Equivalent.
