# Access Compliance Report

| Intersection ID: 6039 | Main Street: DELLINGER_DR | Cross Street: MILHAVEN_LN | Location: SW |
| ADA ID: 0D98CE564D6B | Ramp Type: Directional1 | Initial Pass/Fail: Fail | Overall Compliance: No |

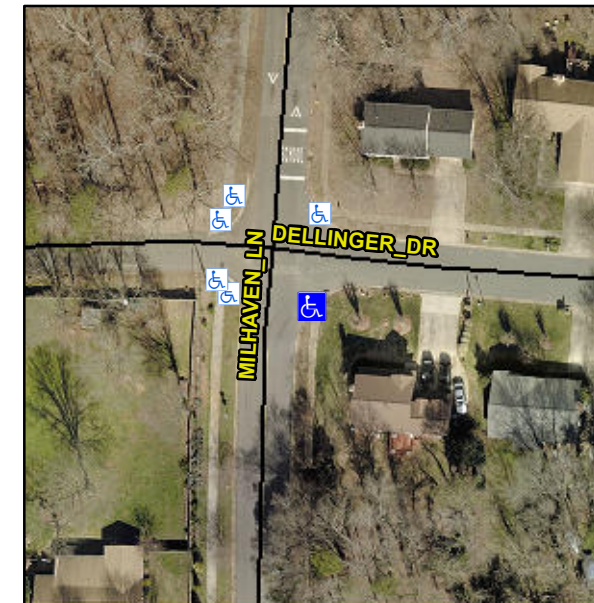
| | | Severity Score: 25 | |

**VEGETATION OVERGROWTH**

**R304.5.3**

| Compliance | Description | Data | Compliance | Description | Data |
|---|---|---|---|---|---|
| No | Ramp XSlope (%) | 7.5 | | | |

**Remove & Replace Entire Ramp.**

Total Cost: \$ 1600.00
