# Access Compliance Report

## Public Rights-of-Way

### (Curb Ramps)

Intersection ID: 43204	Main Street: PLANTAIN_CT	Cross Street: SPEEDWELL_CT	Location: NW
ADA ID: 0D99B65DF9D5	Ramp Type: PerpDiag	Initial Pass/Fail: Fail	Overall Compliance: No
		Severity Score: 10

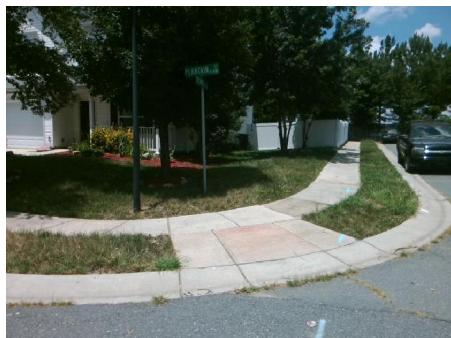
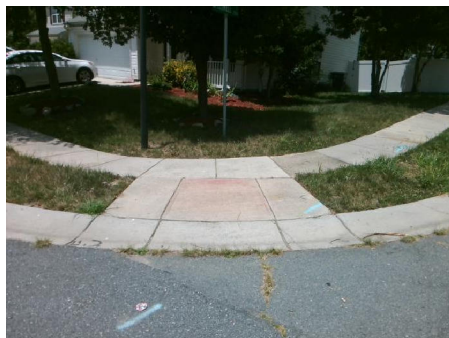
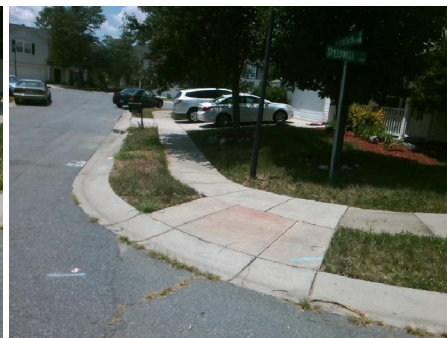
**Not Found, R304.5.1, R304.5.3**

Compliance	Description	Data	Compliance	Description	Data
N/A	Ramp Length (in)	50.0	Yes	Ramp Slope (%)	6.9
No	Ramp Width (in)	41.0	No	Ramp XSlope (%)	4.8
N/A	Flare Type LT	N/A	N/A	Flare Type RT	N/A
N/A	Flare Slope LT (%)	N/A	N/A	Flare Slope RT (%)	N/A
N/A	Flare Traversable LT?	N/A	N/A	Flare Traversable RT?	N/A
N/A	Landing Length (in)	N/A	N/A	DWS Provided?	N/A
N/A	Landing Width (in)	N/A	N/A	DWS Contrast?	N/A
N/A	Landing Slope (%)	N/A	N/A	DWS Length (in)	N/A
N/A	Landing X Slope (%)	N/A	N/A	DWS Full Width?	N/A
N/A	Landing Curb? (Y/N)	N/A	N/A	DWS Offset (in)	N/A
N/A	Shared Landing?	N/A			
N/A	Gutter Ponding?	N/A	N/A	Gutter Slope (%)	N/A
N/A	Gutter Lip Ht (in)	N/A	N/A	Gutter X Slope (%)	N/A
N/A	Painted X Walk1?	No	N/A	Painted X Walk2?	No
	X Walk 1 Direction	To S		X Walk 2 Direction	To E
N/A	X Walk 1 Width (in)	N/A	N/A	X Walk 2 Width (in)	N/A
	X Walk 1 Slope (%)	3.8		X Walk 2 Slope (%)	3.8
	X Walk 1 X Slope (%)	4.8		X Walk 2 X Slope (%)	4.6

N/A	Ramp inside XWalk1?	N/A	N/A	Ramp inside XWalk2?	N/A
	Road Slope (%)	4.2	N/A	Clear Space?	N/A
	Road X Slope (%)	2.5	N/A	Clear Space to XWalk (in)	N/A
N/A	Any Obstructions?	N/A	N/A	Storm Grate/Utility Hazard?	N/A
	Obstruction Type			Storm Grate/Utility Type	
		N/A			N/A
			Yes	Surface Condition? (G/P)	Good

**Remove & Replace Curb Ramp With Two New Directional Ramps or Equivalent.**
