# Access Compliance Report

## Public Rights-of-Way

### (Curb Ramps)

Intersection ID: 50594	Main Street: BEAR_GRASS_LN	Cross Street: GRAY_WILLOW_RD	Location: E
ADA ID: 0D9B8E135957	Ramp Type: Perp	Initial Pass/Fail: Fail	Overall Compliance: No
Severity Score: 21.25			
Codes/Mitigation Info/Possible Solution		Field Measurements/Component Compliance

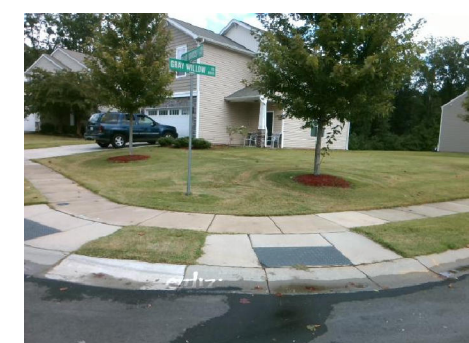
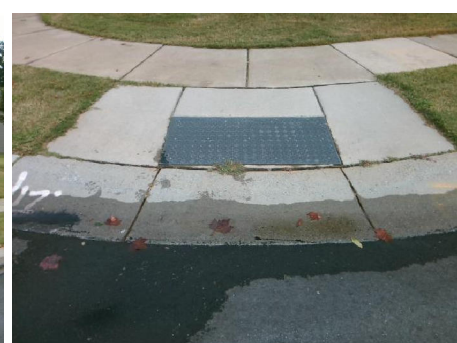
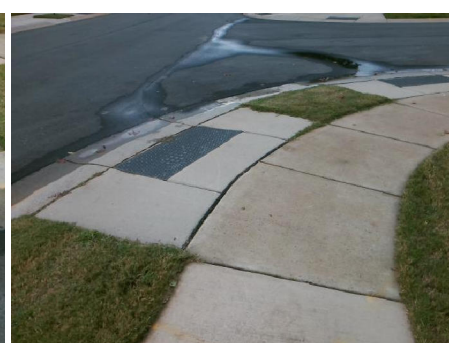
Compliance	Description	Data	Compliance	Description	Data
N/A	Ramp Length (in)	47.0	No	Ramp Slope (%)	9.9
No	Ramp Width (in)	45.0	Yes	Ramp XSlope (%)	0.7
N/A	Flare Type LT	N/A	N/A	Flare Type RT	N/A
N/A	Flare Slope LT (%)	N/A	N/A	Flare Slope RT (%)	N/A
N/A	Flare Traversable LT?	N/A	N/A	Flare Traversable RT?	N/A
N/A	Landing Length (in)	N/A	N/A	DWS Provided?	N/A
N/A	Landing Width (in)	N/A	N/A	DWS Contrast?	N/A
N/A	Landing Slope (%)	N/A	N/A	DWS Length (in)	N/A
N/A	Landing X Slope (%)	N/A	N/A	DWS Full Width?	N/A
N/A	Landing Curb? (Y/N)	N/A	N/A	DWS Offset (in)	N/A
N/A	Shared Landing?	N/A			
N/A	Gutter Ponding?	N/A	N/A	Gutter Slope (%)	N/A
N/A	Gutter Lip Ht (in)	N/A	N/A	Gutter X Slope (%)	N/A
N/A	Painted X Walk1?	No	N/A	Painted X Walk2?	N/A
	X Walk 1 Direction	To SW		X Walk 2 Direction	N/A
N/A	X Walk 1 Width (in)	N/A	N/A	X Walk 2 Width (in)	N/A
	X Walk 1 Slope (%)	3.0		X Walk 2 Slope (%)	N/A
	X Walk 1 X Slope (%)	2.1		X Walk 2 X Slope (%)	N/A

N/A	Ramp inside XWalk1?	N/A	N/A	Ramp inside XWalk2?	N/A
	Road Slope (%)	N/A	N/A	Clear Space?	N/A
	Road X Slope (%)	N/A	N/A	Clear Space to XWalk (in)	N/A
N/A	Any Obstructions?	N/A	N/A	Storm Grate/Utility Hazard?	N/A
	Obstruction Type			Storm Grate/Utility Type	
		N/A			N/A
			Yes	Surface Condition? (G/P)	Good

**Remove & Replace Entire Ramp.**

**Not Found, R304.5.1, R304.2.2**
