Access Compliance Report

Public Rights-of-Way

(Curb Ramps)

Intersection ID: 19093	Main Street: BRAEBURN_RD	Cross Street: GATE_POST_RD	Location: W
ADA ID: 0DAFF024BEEF	Ramp Type: Perp	Initial Pass/Fail: Fail	Overall Compliance: No
		Severity Score: 25

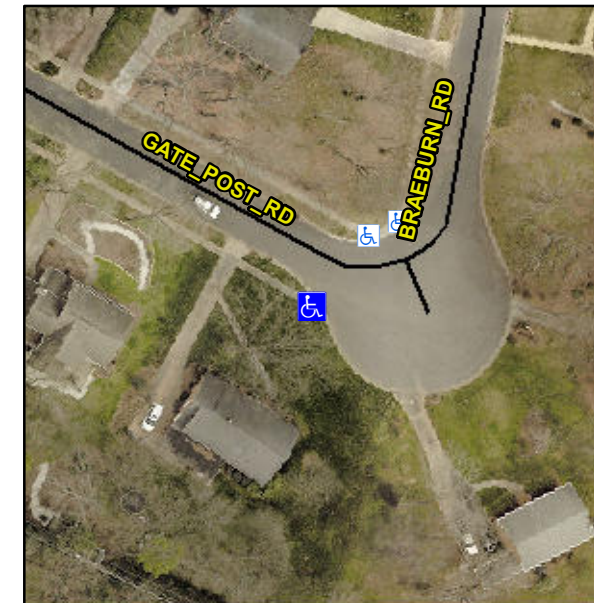
Not Found, R304.2.2, R304.5.3

Compliance	Description	Data	Compliance	Description	Data
N/A	Ramp Length (in)	48.0	No	Ramp Slope (%)	11.0
Yes	Ramp Width (in)	48.0	No	Ramp XSlope (%)	5.5
N/A	Flare Type LT	N/A	N/A	Flare Type RT	N/A
N/A	Flare Slope LT (%)	N/A	N/A	Flare Slope RT (%)	N/A
N/A	Flare Traversable LT?	N/A	N/A	Flare Traversable RT?	N/A
N/A	Landing Length (in)	N/A	N/A	DWS Provided?	N/A
N/A	Landing Width (in)	N/A	N/A	DWS Contrast?	N/A
N/A	Landing Slope (%)	N/A	N/A	DWS Length (in)	N/A
N/A	Landing X Slope (%)	N/A	N/A	DWS Full Width?	N/A
N/A	Landing Curb? (Y/N)	N/A	N/A	DWS Offset (in)	N/A
N/A	Shared Landing?	N/A			
N/A	Gutter Ponding?	N/A	N/A	Gutter Slope (%)	N/A
N/A	Gutter Lip Ht (in)	N/A	N/A	Gutter X Slope (%)	N/A
N/A	Painted X Walk1?	No	N/A	Painted X Walk2?	N/A
	X Walk 1 Direction	To NE		X Walk 2 Direction	N/A
N/A	X Walk 1 Width (in)	N/A	N/A	X Walk 2 Width (in)	N/A
	X Walk 1 Slope (%)	2.5		X Walk 2 Slope (%)	N/A
	X Walk 1 X Slope (%)	3.1		X Walk 2 X Slope (%)	N/A

N/A	Ramp inside XWalk1?	N/A	N/A	Ramp inside XWalk2?	N/A
	Road Slope (%)	N/A	N/A	Clear Space?	N/A
	Road X Slope (%)	N/A	N/A	Clear Space to XWalk (in)	N/A
N/A	Any Obstructions?	N/A	N/A	Storm Grate/Utility Hazard?	N/A
	Obstruction Type			Storm Grate/Utility Type	
		N/A			N/A
			Yes	Surface Condition? (G/P)	Good

Possible Solutions:

Remove & Replace Entire Ramp.

Total Cost: \$ 1850.00
