Access Compliance Report

Public Rights-of-Way

(Curb Ramps)

Intersection ID: N/A	Main Street: BROOKVALE_ST	Cross Street: HORACE_ST	Location: S
ADA ID: 0DB2C53F01B8	Ramp Type: Perp	Initial Pass/Fail: Fail	Overall Compliance: No
Severity Score: 12.5			
Codes/Mitigation Info/Possible Solution		Field Measurements/Component Compliance

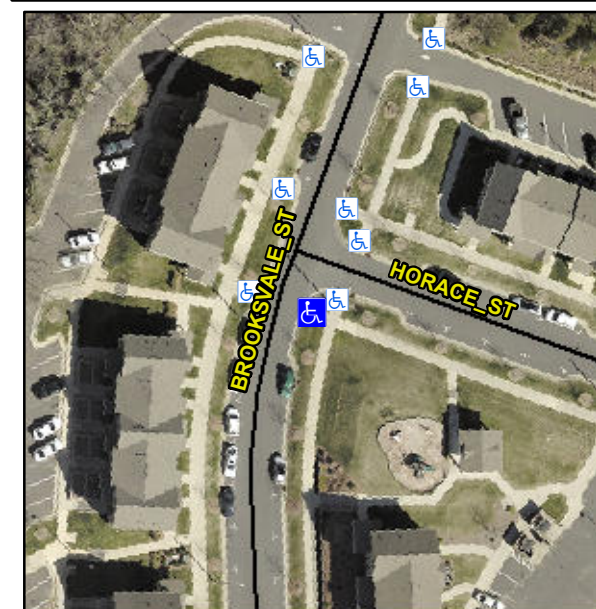
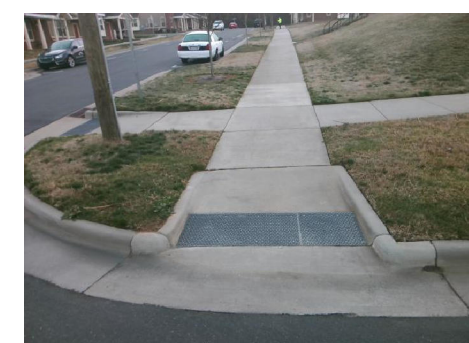
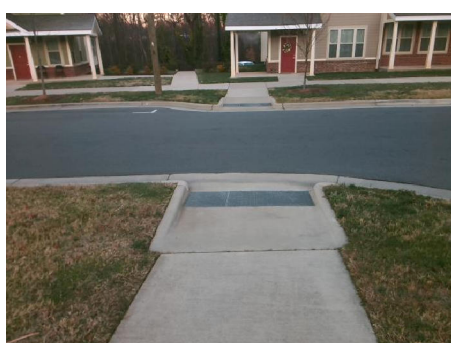
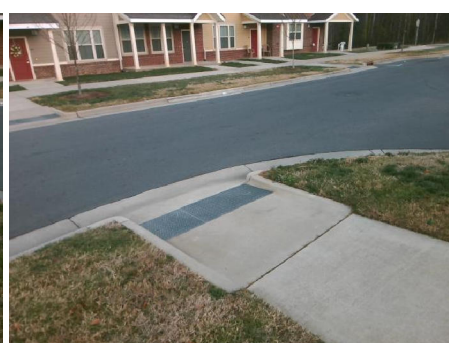
Compliance	Description	Data	Compliance	Description	Data
N/A	Ramp Length (in)	71.0	No	Ramp Slope (%)	11.0
Yes	Ramp Width (in)	70.0	Yes	Ramp XSlope (%)	0.9
N/A	Flare Type LT	N/A	N/A	Flare Type RT	N/A
N/A	Flare Slope LT (%)	N/A	N/A	Flare Slope RT (%)	N/A
N/A	Flare Traversable LT?	N/A	N/A	Flare Traversable RT?	N/A
N/A	Landing Length (in)	N/A	N/A	DWS Provided?	N/A
N/A	Landing Width (in)	N/A	N/A	DWS Contrast?	N/A
N/A	Landing Slope (%)	N/A	N/A	DWS Length (in)	N/A
N/A	Landing X Slope (%)	N/A	N/A	DWS Full Width?	N/A
N/A	Landing Curb? (Y/N)	N/A	N/A	DWS Offset (in)	N/A
N/A	Shared Landing?	N/A			
N/A	Gutter Ponding?	N/A	N/A	Gutter Slope (%)	N/A
N/A	Gutter Lip Ht (in)	N/A	N/A	Gutter X Slope (%)	N/A
N/A	Painted X Walk1?	No	N/A	Painted X Walk2?	N/A
	X Walk 1 Direction	To NW		X Walk 2 Direction	N/A
N/A	X Walk 1 Width (in)	N/A	N/A	X Walk 2 Width (in)	N/A
	X Walk 1 Slope (%)	2.1		X Walk 2 Slope (%)	N/A
	X Walk 1 X Slope (%)	1.4		X Walk 2 X Slope (%)	N/A

N/A	Ramp inside XWalk1?	N/A	N/A	Ramp inside XWalk2?	N/A
	Road Slope (%)	N/A	N/A	Clear Space?	N/A
	Road X Slope (%)	N/A	N/A	Clear Space to XWalk (in)	N/A
N/A	Any Obstructions?	N/A	N/A	Storm Grate/Utility Hazard?	N/A
	Obstruction Type			Storm Grate/Utility Type	
		N/A			N/A
			Yes	Surface Condition? (G/P)	Good

Possible Solutions:

Remove & Replace Entire Ramp.

R304.2.2

\$ 1850.00
