Access Compliance Report Public Rights-of-Way (Curb Ramps)

Intersection ID: 47844	Main Street: DEL_RIO_RD			treet:	SERAPE_RD	Location:	SE		
ADA ID: 0DBC3AE6F0B1	Ramp Type: PerpDiag			ass/Fa	ail: Fail Overall C	o Severity Score:	21.25		
Codes/Mitigation Info/Possible Solution				Field Measurements/Component Compliance					
		Possible Solutions:		Compliance Description			Data Compliance Description		Data
	SERVE FD	Remove & Replace Curb Ramp V	Vith	N/A	Ramp Length (in)	59.0	Yes	Ramp Slope (%)	6.9
		Two New Directional Ramps or		No	Ramp Width (in)	45.0	No	Ramp XSlope (%)	5.1
		Equivalent.		N/A	Flare Type LT	N/A	N/A	Flare Type RT	N/A
				N/A	Flare Slope LT (%)	N/A	N/A	Flare Slope RT (%)	N/A
				N/A	Flare Traversable LT?	N/A	N/A	Flare Traversable RT?	N/A
La Barris				N/A	Landing Length (in)	N/A	N/A	DWS Provided?	N/A
6		Surveyor Notes:		N/A	Landing Width (in)	N/A	N/A	DWS Contrast?	N/A
		N/A		N/A	Landing Slope (%)	N/A	N/A	DWS Length (in)	N/A

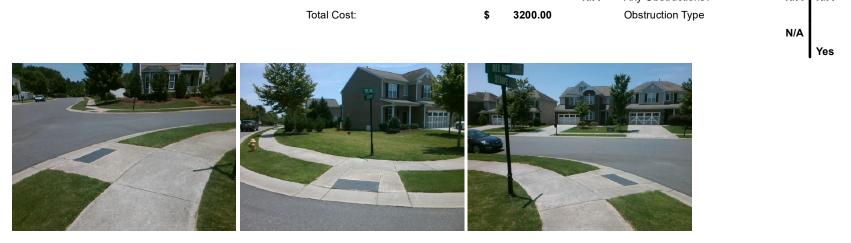
t. I			N/A	Landing X Slope (%)	N/A	N/A	DWS Full Width?	N/A
E D .	A A			N/A	Landing Curb? (Y/N)	N/A	N/A	DWS Offset (in)	N/A
	A ST COMPANY			N/A	Shared Landing?	N/A		()	
TA THAT I WE	The second is a second	PROW/ADA:		N/A	Gutter Ponding?	N/A	N/A	Gutter Slope (%)	N/A
		Not Found, R304.5.1, R304.5.3		N/A	Gutter Lip Ht (in)	N/A	N/A	Gutter X Slope (%)	N/A
and the second second	the state	Not Found, K304.5.1, K304.5.5		N/A	Painted X Walk1?	No	N/A	Painted X Walk2?	No
Street 1 Name SERAPE RD				N/A	X Walk 1 Direction	To N		X Walk 2 Direction	To W
				N/A	X Walk 1 Width (in)	N/A	N/A	X Walk 2 Width (in)	N/A
				IN/A		2.6	N/A		1.6

-				X Walk 1 Slope (%)	2.0 1.9		X Walk 2 Slope (%)	
Stop Condition-Street 2	StopSign			N1/A	X Walk 1 X Slope (%)			X Walk 2 X Slope (%)	1.6
Street 2 Name	DEL RIO RD			N/A	Ramp inside XWalk1?	N/A	N/A	Ramp inside XWalk2?	N/A
Stop Condition-Street 1	None				Road Slope (%)	2.0	N/A	Clear Space?	N/A
					Road X Slope (%)	0.5	N/A	Clear Space to XWalk (in)	N/A
				N/A	Any Obstructions?	N/A	N/A	Storm Grate/Utility Hazard?	N/A
		Total Cost: \$ 3	200.00		Obstruction Type			Storm Grate/Utility Type	
						N/A			N/A
