# Access Compliance Report

## Public Rights-of-Way

### (Curb Ramps)

Intersection ID: 3033	Main Street: DEARMON_RD	Cross Street: BENFIELD_RD	Location:	W
ADA ID: 0DCB26CB1347	Ramp Type: Perp	Initial Pass/Fail: Fail	Overall Compliance: No	Severity Score: 12.5

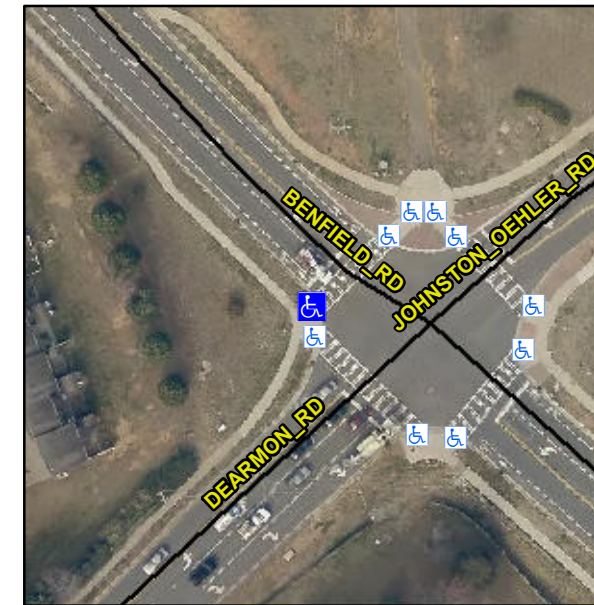
Compliance	Description	Data	Compliance	Description	Data
N/A	Ramp Length (in)	95.5	No	Ramp Slope (%)	11.2
Yes	Ramp Width (in)	83.0	Yes	Ramp XSlope (%)	1.3
N/A	Flare Type LT	N/A	N/A	Flare Type RT	N/A
N/A	Flare Slope LT (%)	N/A	N/A	Flare Slope RT (%)	N/A
N/A	Flare Traversable LT?	N/A	N/A	Flare Traversable RT?	N/A
N/A	Landing Length (in)	N/A	N/A	DWS Provided?	N/A
N/A	Landing Width (in)	N/A	N/A	DWS Contrast?	N/A
N/A	Landing Slope (%)	N/A	N/A	DWS Length (in)	N/A
N/A	Landing X Slope (%)	N/A	N/A	DWS Full Width?	N/A
N/A	Landing Curb? (Y/N)	N/A	N/A	DWS Offset (in)	N/A
N/A	Shared Landing?	N/A			
N/A	Gutter Ponding?	N/A	N/A	Gutter Slope (%)	N/A
N/A	Gutter Lip Ht (in)	N/A	N/A	Gutter X Slope (%)	N/A
N/A	Painted X Walk1?	Yes	N/A	Painted X Walk2?	N/A
	X Walk 1 Direction	To NE		X Walk 2 Direction	N/A
N/A	X Walk 1 Width (in)	112.0	N/A	X Walk 2 Width (in)	N/A
	X Walk 1 Slope (%)	1.4		X Walk 2 Slope (%)	N/A
	X Walk 1 X Slope (%)	0.9		X Walk 2 X Slope (%)	N/A

N/A	Ramp inside XWalk1?	Yes	N/A	Ramp inside XWalk2?	N/A
	Road Slope (%)	N/A	N/A	Clear Space?	N/A
	Road X Slope (%)	N/A	N/A	Clear Space to XWalk (in)	N/A
N/A	Any Obstructions?	N/A	N/A	Storm Grate/Utility Hazard?	N/A
	Obstruction Type			Storm Grate/Utility Type	
		N/A			N/A
			Yes	Surface Condition? (G/P)	Good

Possible Solutions:

**Remove & Replace Entire Ramp.**

**R304.2.2**

**\$ 1850.00**
