Access Compliance Report

Public Rights-of-Way

(Curb Ramps)

Intersection ID: 19845	Main Street: CECILIA_LN	Cross Street: KELBURN_LN	Location: S
ADA ID: 0DE5C694C37C	Ramp Type: Perp	Initial Pass/Fail: Fail	Overall Compliance: No
			Severity Score: 21.25

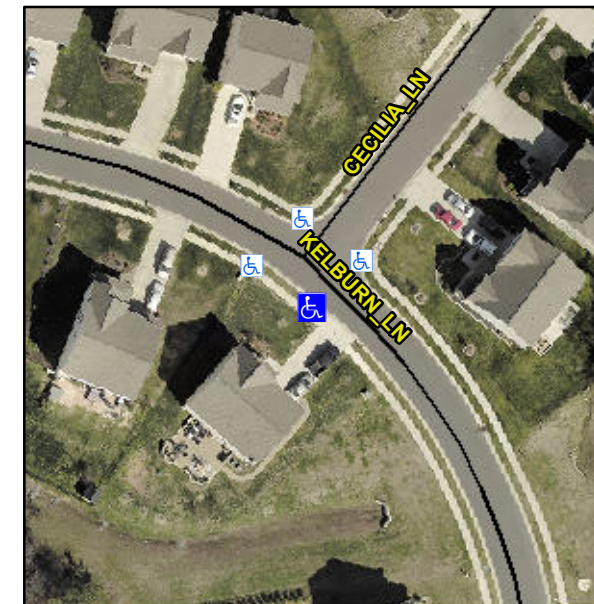
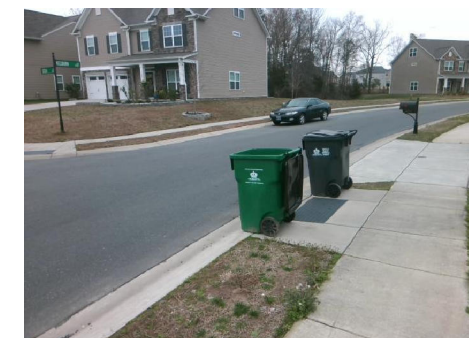
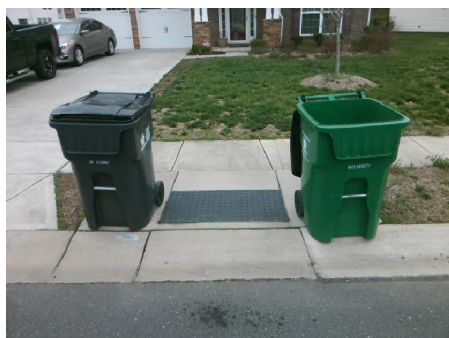
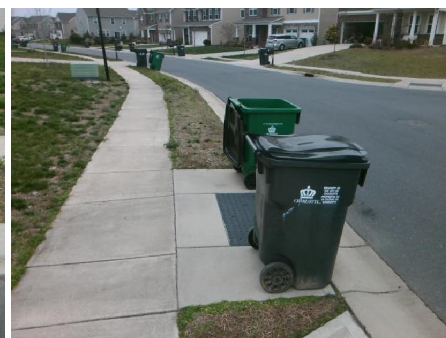
Not Found, R304.5.1, R304.2.2

Compliance	Description	Data	Compliance	Description	Data
N/A	Ramp Length (in)	47.0	No	Ramp Slope (%)	9.1
No	Ramp Width (in)	46.5	Yes	Ramp XSlope (%)	1.1
N/A	Flare Type LT	N/A	N/A	Flare Type RT	N/A
N/A	Flare Slope LT (%)	N/A	N/A	Flare Slope RT (%)	N/A
N/A	Flare Traversable LT?	N/A	N/A	Flare Traversable RT?	N/A
N/A	Landing Length (in)	N/A	N/A	DWS Provided?	N/A
N/A	Landing Width (in)	N/A	N/A	DWS Contrast?	N/A
N/A	Landing Slope (%)	N/A	N/A	DWS Length (in)	N/A
N/A	Landing X Slope (%)	N/A	N/A	DWS Full Width?	N/A
N/A	Landing Curb? (Y/N)	N/A	N/A	DWS Offset (in)	N/A
N/A	Shared Landing?	N/A			
N/A	Gutter Ponding?	N/A	N/A	Gutter Slope (%)	N/A
N/A	Gutter Lip Ht (in)	N/A	N/A	Gutter X Slope (%)	N/A
N/A	Painted X Walk1?	No	N/A	Painted X Walk2?	N/A
	X Walk 1 Direction	To NE		X Walk 2 Direction	N/A
N/A	X Walk 1 Width (in)	N/A	N/A	X Walk 2 Width (in)	N/A
	X Walk 1 Slope (%)	1.6		X Walk 2 Slope (%)	N/A
	X Walk 1 X Slope (%)	1.1		X Walk 2 X Slope (%)	N/A

Remove & Replace Entire Ramp.
