Access Compliance Report

Public Rights-of-Way

(Curb Ramps)

| Intersection ID: 10031761 | Main Street: MIDWAY_PARK_DR | Cross Street: N/A | Location: W |

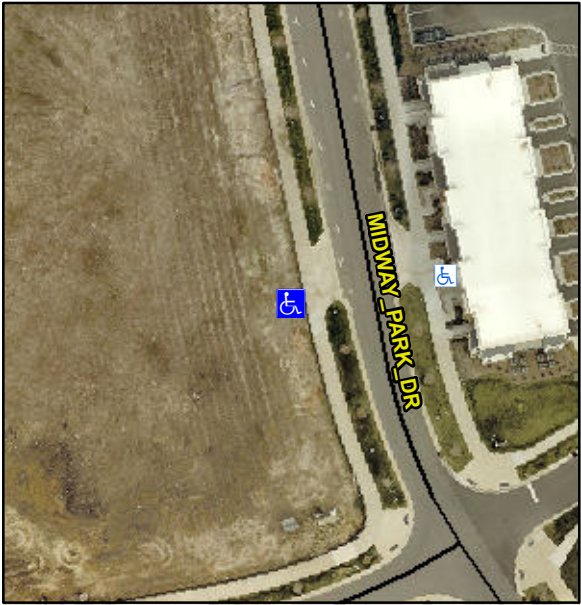
| ADA ID: 0DE8934C1C52 | Ramp Type: Perp | Initial Pass/Fail: Fail | Overall Compliance: No |
| | | | Severity Score: 13.75 |

| Codes/Mitigation Info/Possible Solution | | | Field Measurements/Component Compliance | | |
|--|--|--|---|---|---|
| | Remove & Replace Entire Ramp. | | No | Ramp Length (in) | 45.0 |
| <p>Surveyor Notes:</p> <p>N/A</p> <p>PROW/ADA:</p> <p>R304.2.2, R304.5.3</p> | | | N/A | Flare Type RT | N/A |

| Codes/Mitigation Info/Possible Solution | | | Field Measurements/Component Compliance | | |
|--|--|--|---|---|---|
| | Possible Solutions: | | Compliance | Description | Data |
| <p>Total Cost:</p> <p>\$ 1850.00</p> | | | N/A | Gutter Lip Ht (in) | N/A |
