Access Compliance Report Public Rights-of-Way (Curb Ramps)

Intersection ID: 10220 Main Street: N_DAVIDSON_ST Cross Street: E_33RD_ST Location: N

ADA ID: 0DED8C2BD959 Ramp Type: Perp Initial Pass/Fail: Fail Overall Compliance: No Severity Score: 25

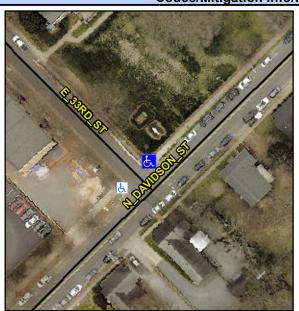
Street 1 Name E 33RD ST
Stop Condition-Street 2 StopSign
Street 2 Name N/A
Stop Condition-Street 1 N/A

Possible Solutions:					
Remove & Replace Entire Ramp.					
Surveyor Notes:					
N/A					
PROW/ADA:					
Not Found, R304.2.2, R304.5.3					
ı
